NORTH AMERICAN ELECTRIC RELIABILITY COUNCIL

Technical Analysis of the August 14, 2003, Blackout: *What Happened, Why, and What Did We Learn?*

**Report to the NERC Board of Trustees
by the NERC Steering Group**

July 13, 2004

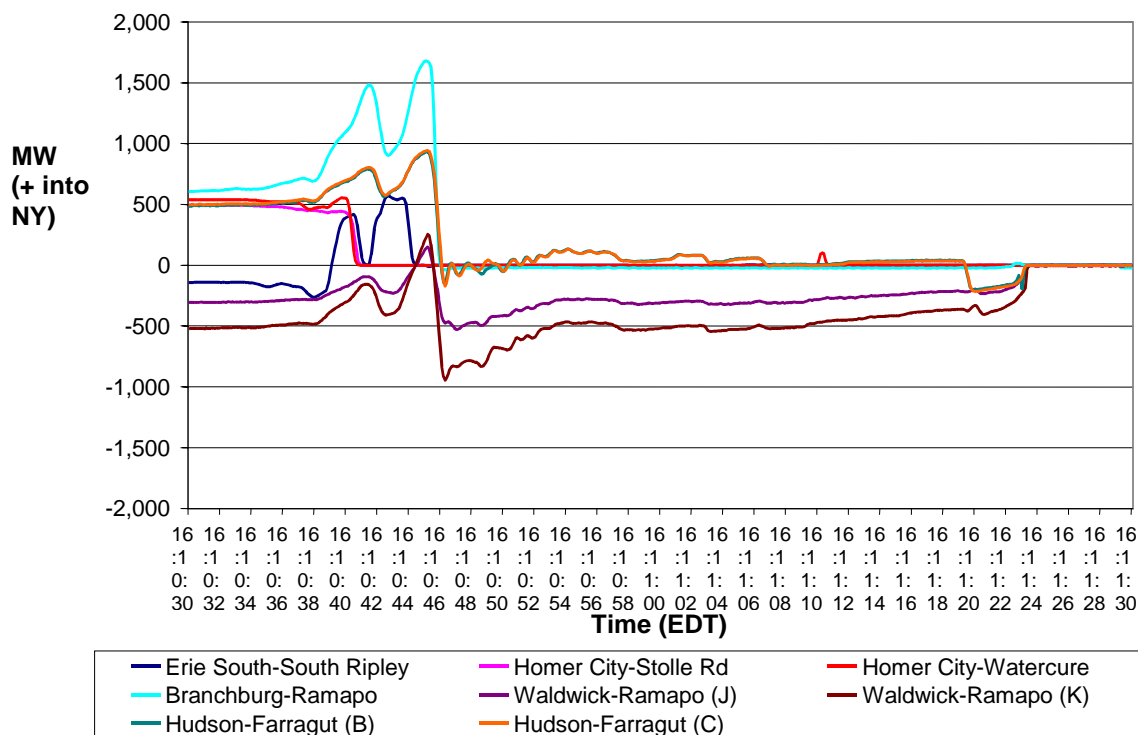
Figure IV.28 — PJM to New York Ties Disconnect

As shown in Figure IV.27, the 69-mile long Branchburg-Ramapo line and Ramapo transformer between New Jersey and New York was the last major transmission path remaining between the Eastern Interconnection and the area ultimately affected by the blackout. Figure IV.28 shows how that line disconnected at 16:10:45, along with other underlying 230 and 138-kV lines in northeastern New Jersey. Branchburg-Ramapo was carrying over 3,000 MVA and 4,500 amps with voltage at 79 percent before it tripped, either on a high-speed swing into zone 1 or on a direct transfer trip. The investigation team is still examining why the higher impedance 230-kV overhead lines tripped while the underground Hudson-Farragut 230-kV cables did not; the available data suggest that the lower impedance of underground cables made these less vulnerable to the electrical strain placed on the system.

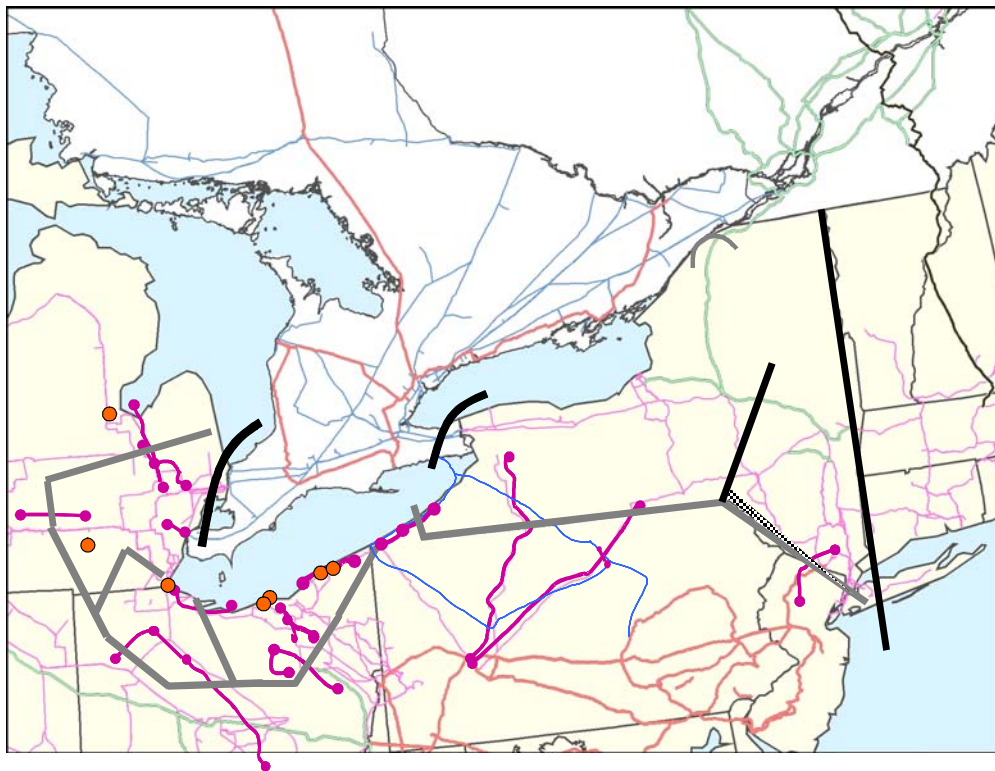
Figure IV.29 — New York and New England Separate, Multiple Islands Form

- New York-New England upstate transmission lines disconnected: 16:10:46 to 16:10:47
- New York transmission system split along Total East interface: 16:10:49
- The Ontario system just west of Niagara Falls and west of St. Lawrence separated from the western New York island: 16:10:50

Figure VI.29 illustrates the events of this phase.

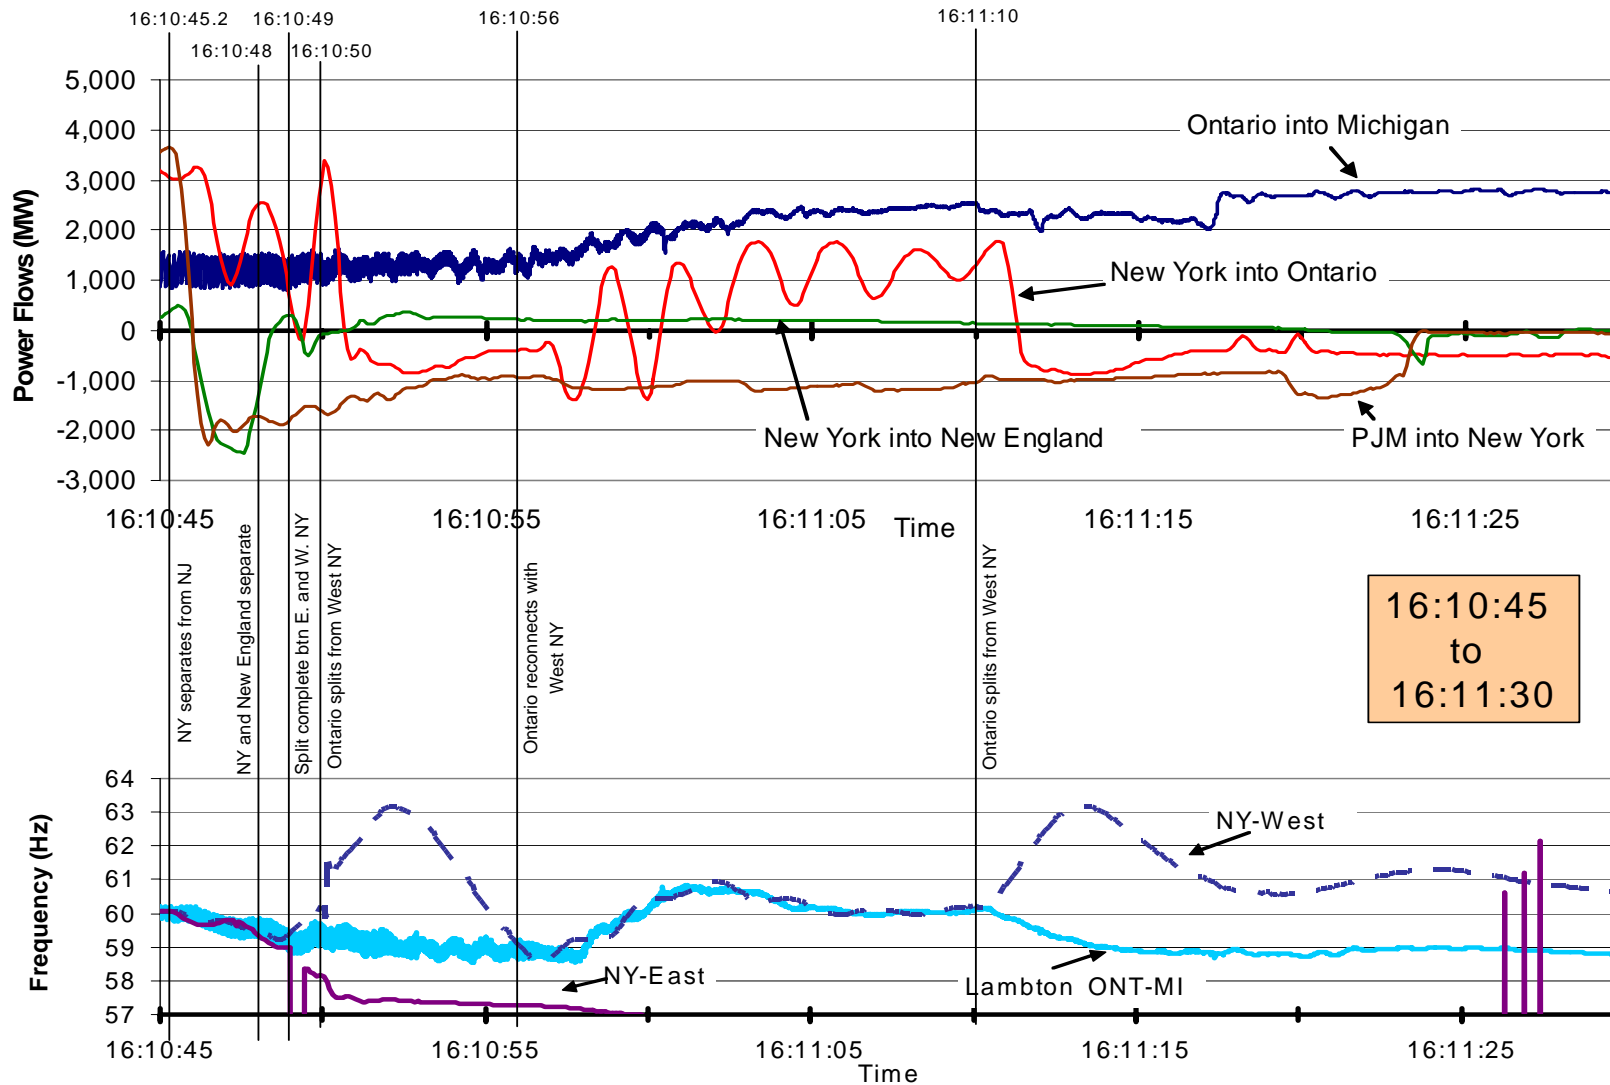
Figure IV.30 — Measured Power Flows and Frequency Across Regional Interfaces, 16:10:45 to 16:11:30, With Key Events in the Cascade

The entire northeastern system was experiencing large scale, dynamic oscillations during this period. Even if the UFLS and generation had been perfectly balanced at any moment in time, these oscillations would have made stabilization difficult and unlikely. Figure IV.30 gives an overview of the power flows and frequencies during the period 16:10:45 through 16:11:00, capturing most of the key events in the final phase of the cascade.

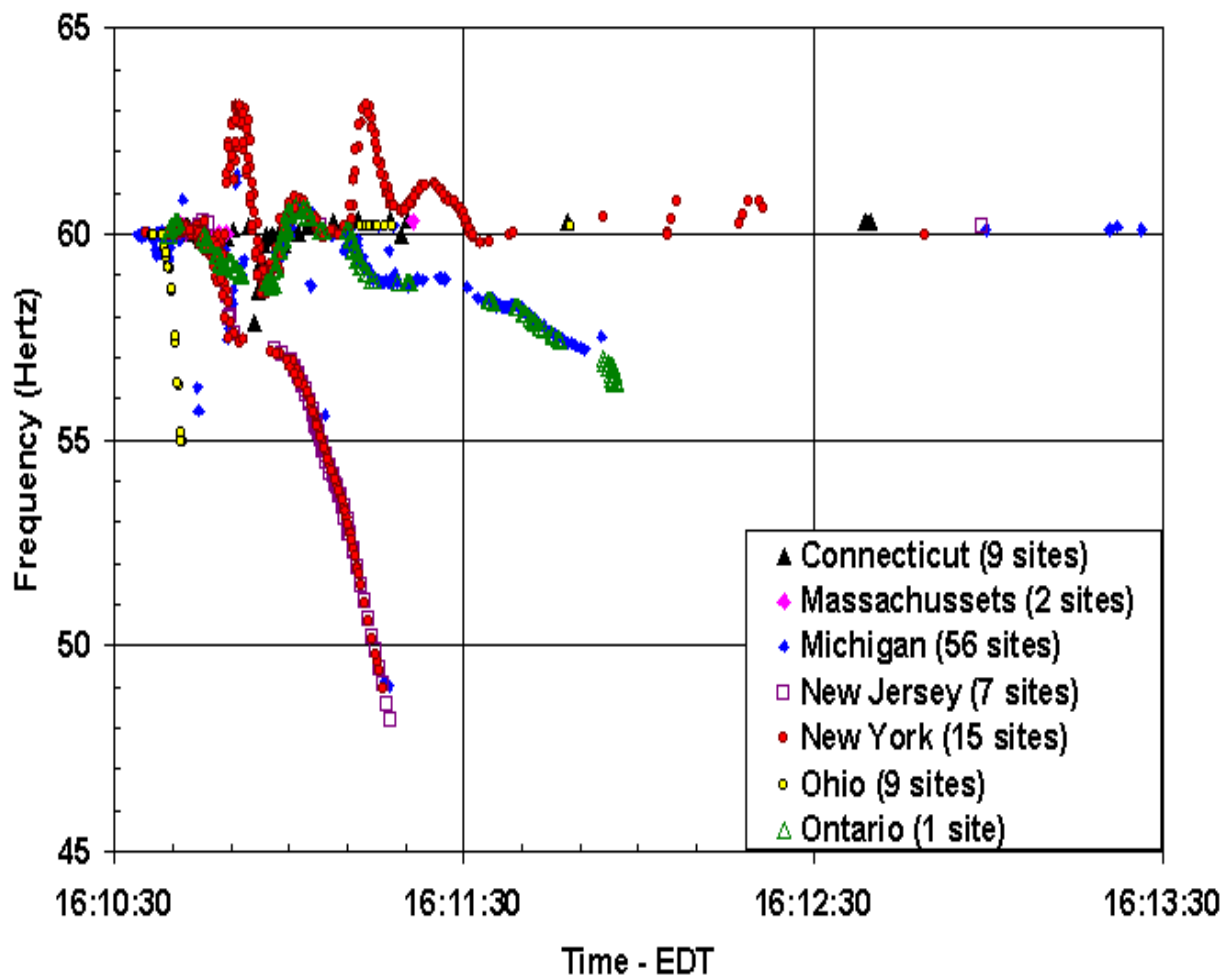
Figure IV.32 — Electric Islands Reflected in Frequency Plot

Figure IV.32 shows frequency data collected by the distribution-level monitors of Softswitching Technologies, Inc. (a commercial power quality company serving industrial customers) for the area affected by the blackout. The data reveal at least five separate electrical islands in the Northeast as the cascade progressed. The two paths of red circles on the frequency scale reflect the Albany area island (upper path) versus the New York City island, which declined and blacked out much earlier.

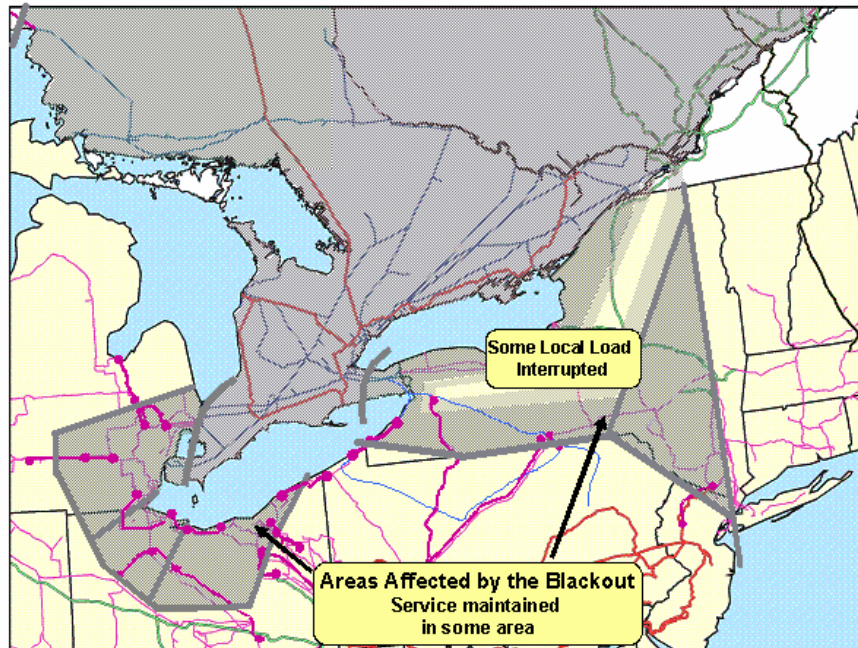
Figure IV.33 — Areas Affected by the Blackout

Most of the Northeast (the area shown in gray in Figure VI.33) had now blacked out. Some isolated areas of generation and load remained on-line for several minutes. Some of those areas in which a close generation-demand balance could be maintained remained operational.

One relatively large island remained in operation, serving about 5,700 MW of demand, mostly in western New York. Ontario's large Beck and Saunders hydro stations, along with some Ontario load, the NYPA Niagara and St. Lawrence hydro stations, and NYPA's 765-kV AC interconnection with Québec, remained connected to the western New York system, supporting demand in upstate New York. This island formed the basis for restoration in both New York and Ontario.

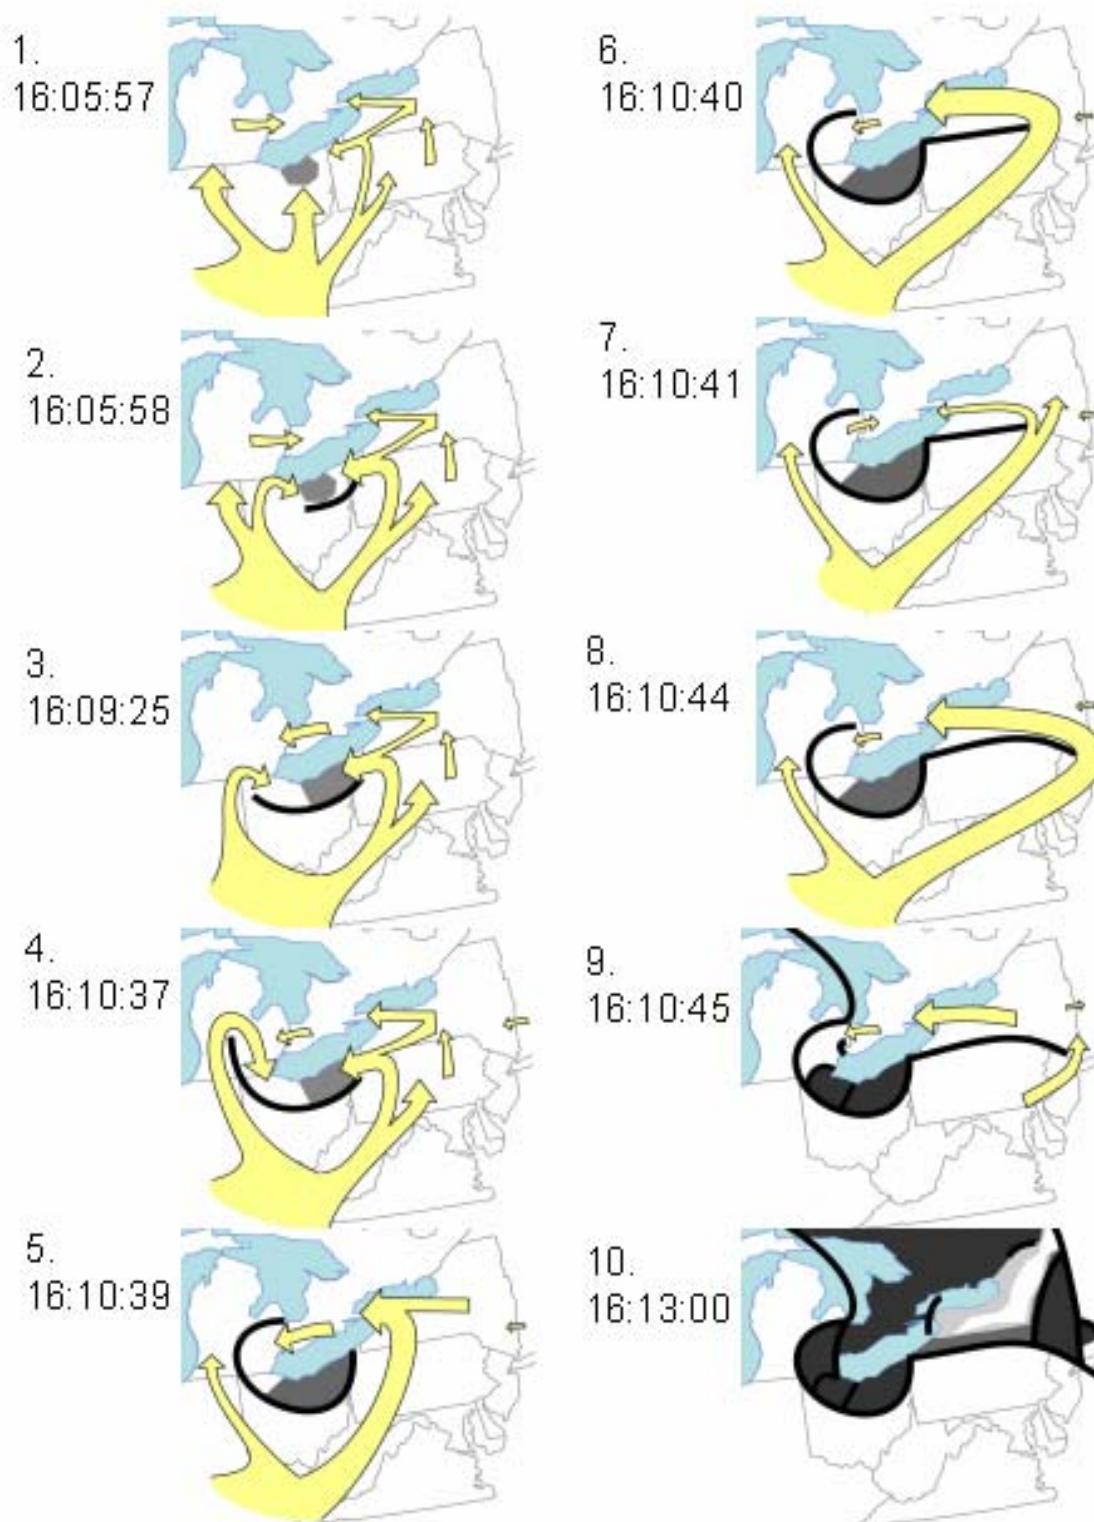
Figure IV.34 — Cascade Sequence Summary

The entire cascade sequence is summarized graphically in figure VI.34.
