**NERC**

# Multiple Solar PV Disturbances in CAISO

Disturbances between June and August 2021  
Joint NERC and WECC Staff Report

April 2022

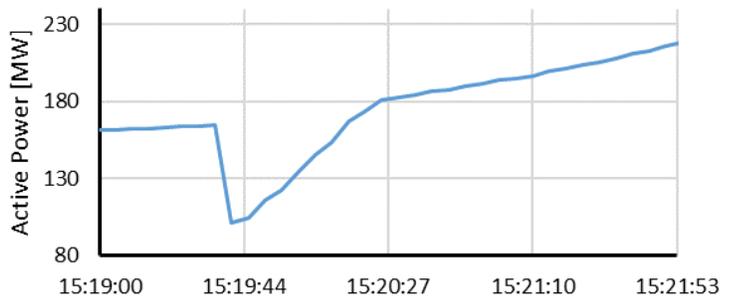
**Plant G**

This plant has been involved in past disturbances and includes legacy inverters with momentary cessation settings enabled of 0.875 pu voltage, 1,000 ms time delay to start active power recovery, and an active power ramp rate of 8.2%/second. The plant should return to predisturbance levels around 13 seconds after the fault; however, the facility took 40 seconds to predisturbance levels. This indicated that plant-level controller interactions are inhibiting the facility from recovering after faults. This issue has been identified in past events and has not been addressed by CAISO. However, NERC coordinated with the GO and they have made changes to the plant-level controller to mitigate this interaction in the future.

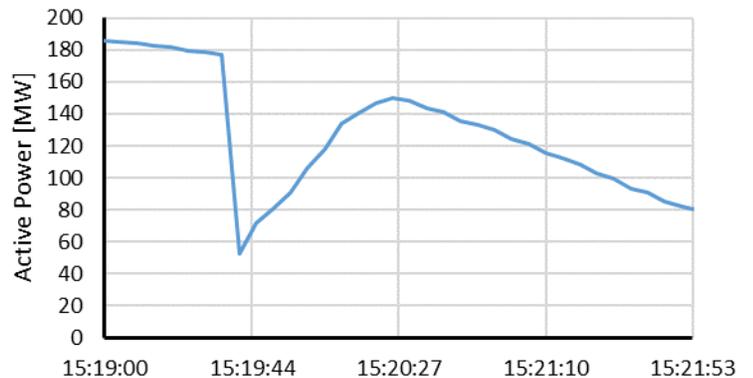
**Plant H**

This plant has been involved in past disturbances and includes legacy inverters with momentary cessation settings enabled of 0.875 pu voltage, 1,000 ms time delay to start active power recovery, and an active power ramp rate of 8.2%/second. The plant should return to predisturbance levels around 13 seconds after the fault; however, the facility took 50 seconds to predisturbance levels. This indicated that plant-level controller interactions are inhibiting the facility from recovering after faults. This issue has been identified in past events and has not been addressed by CAISO. However, NERC coordinated with the GO and they have made changes to the plant-level controller to mitigate this interaction in the future.

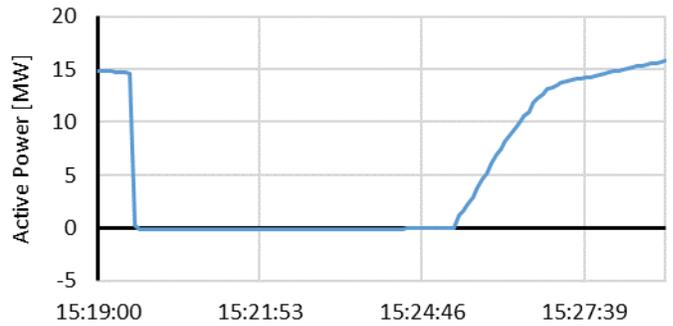
**Plant L**

All on-line inverters tripped on ac overcurrent protection at 150% of rated current. Inverters returned to predisturbance levels in about seven minutes. These inverters have momentary cessation enabled with a low voltage threshold of 0.85 pu and a time delay before initiating active power recovery upon voltage restoration of 100 ms.

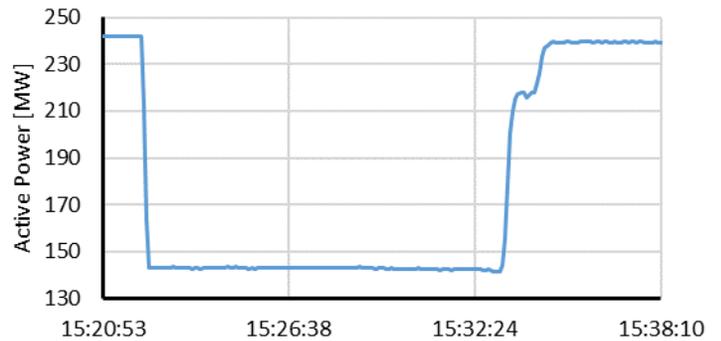
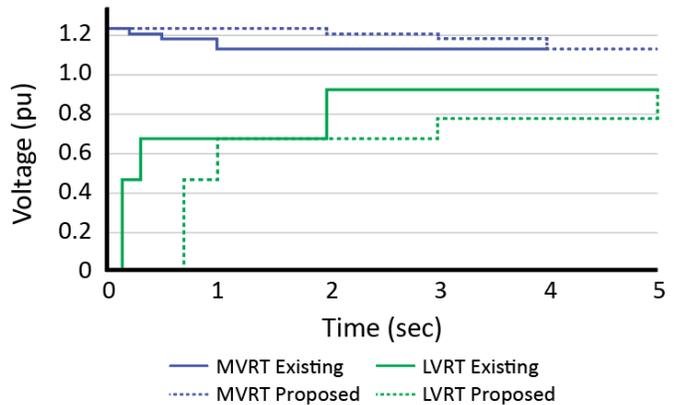
**Plant M**

One hundred ninety-two inverters reduced power output for a total reduction of 100 MW. The inverters remained off-line for 11 minutes before returning to predisturbance levels. The reduction was initially indicated as “momentary cessation”: however, this performance characteristic is not indicative of momentary cessation. Follow-up analysis identified that the plant tripped on “low voltage” although no further information is available. Since the plant personnel did not have access to in-service protection and control settings, the inverter manufacturer was engaged and informed the plant owner that voltage protection settings can be extended. The original settings were nearly identical to PRC-024-3 voltage trip curves whereas the proposed settings significantly improved the operational ride-through capabilities and are likely based on physical equipment limitations.

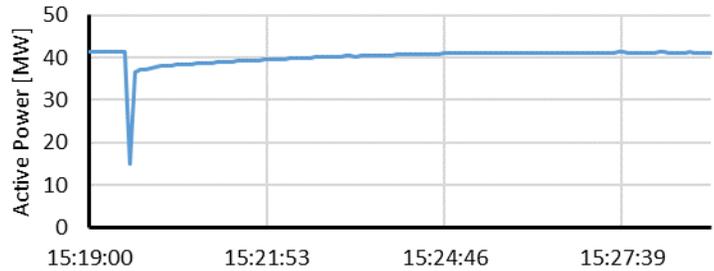
**Plant N**

The analysis team was unable to contact the plant owner/operator, and CAISO was unable to provide any contact information. Therefore, the cause of the reduction remains unknown.

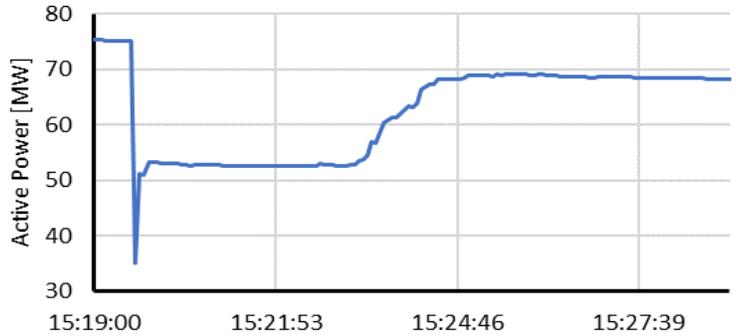
**Plant W**

This plant experienced both momentary cessation and inverter tripping. The plant owner provided 5-minute SCADA data that did not show the event. The 4-second SCADA data from the TOP identified that both momentary cessation and inverter tripping were involved. The plant owner indicated that only one inverter tripped; however, this is not true based on the SCADA data. It is suspected that inverters entered momentary cessation of which 40 MW of reduction was captured by SCADA. In addition, about 22.5 MW reduction is attributed to inverter tripping. The plant recovered to about 5 MW less than predisturbance levels in about five minutes; however, the remaining inverter had to be manually reset, which did not happen until the next morning. The inability of the plant owner to provide detailed information led to an inconclusive cause of tripping at this facility.

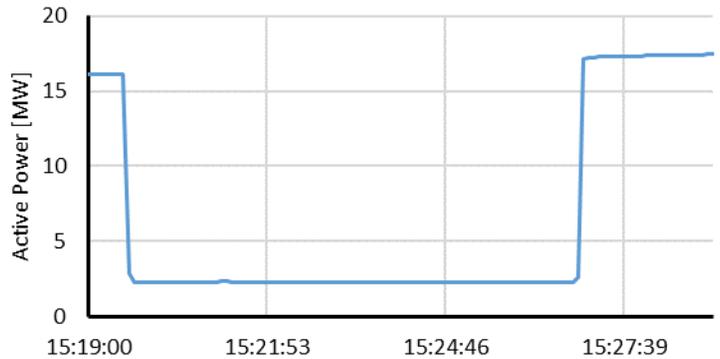
**Plant AA**

All inverters except one tripped on a “slow low frequency” fault code. The inverters have low frequency trip settings of 57 Hz for 0.0 seconds, 57 Hz for 0.02 seconds, and 59.3 Hz for 0.02 seconds. The plant owner was unable to identify which threshold initiated tripping. It is suspected that the 59.3 Hz for 0.02 seconds threshold initiated.<sup>43</sup> The plant returned to predisturbance output levels about 6.5 minutes later.

<sup>43</sup> As observed in the Blue Cut Fire, instantaneous or near-instantaneous frequency trip settings will erroneously operate during faults. A filtered frequency measurement over a time window is needed to avoid unnecessary frequency protection operations. Protection settings should also be based on equipment capabilities. NERC has recommended the plant owner adjust frequency protection timers be set based on equipment capabilities and extended to at least 100 ms for the fastest trip timer (if not longer).

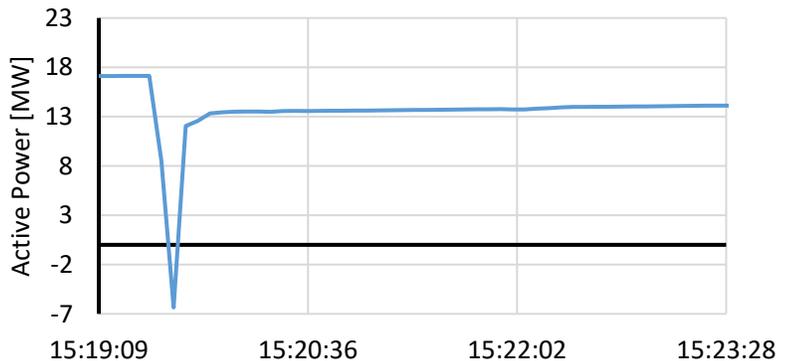
**Plant AB**

Three inverters tripped on ac overcurrent at 150% of rated current. Other inverters entered momentary cessation and recovered quickly (unable to identify exact timing due to poor data resolution). Those inverters are set with momentary cessation settings of 0.9 pu voltage (with 0.1 second delay to start active power recovery) and “no programmed ramp rate (should return to full output in < one second).” These inverters are unable to eliminate momentary cessation or modify settings.

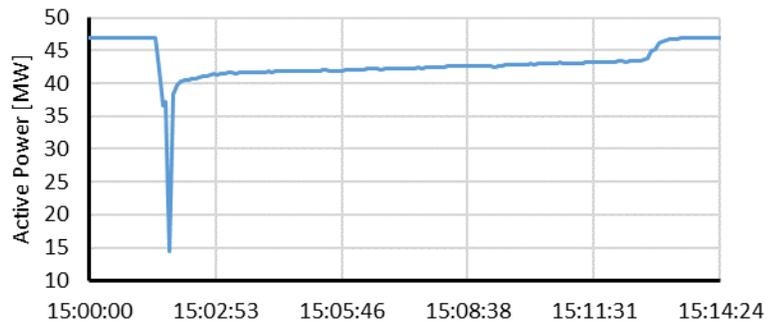
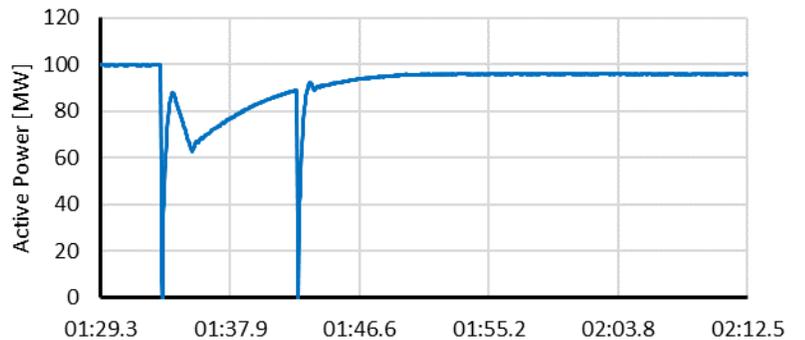
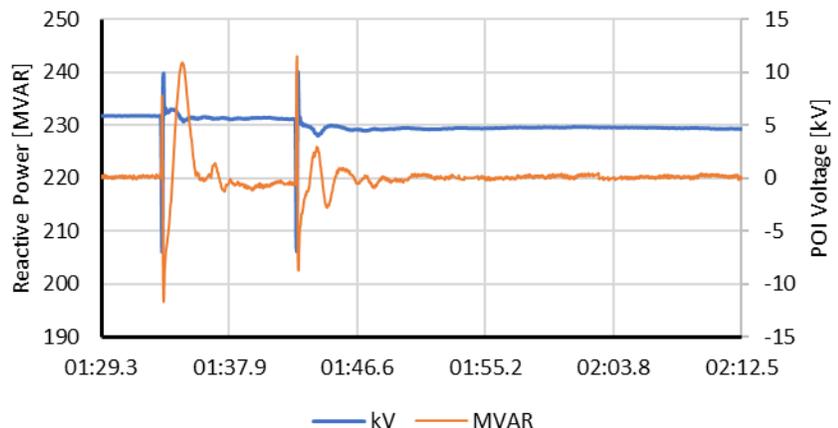
**Plant B**

This plant includes inverters that were initially programmed with momentary cessation; however, momentary cessation was disabled following the NERC alert. This plant now provides reactive power support during low voltage events but active power is sacrificed and its recovery to predisturbance levels is relatively slow (i.e., does not meet the recommendations of the NERC reliability guidelines). For this event, active power goes to zero for both faults. In follow-up conversations with the inverter manufacturer, the active power response going to zero is not reasonable for the settings provided by the plant owner/operator, and this response appears to involve an abnormal interaction between the plant-level controller and the inverters. Active power also recovers but is then pulled back and then slowly recovers to predisturbance levels after about 12–15 seconds. This is not an expected response and does not support grid frequency stability. The plant-level controller is interacting with the inverter controls, resulting in a slower recovery than expected.

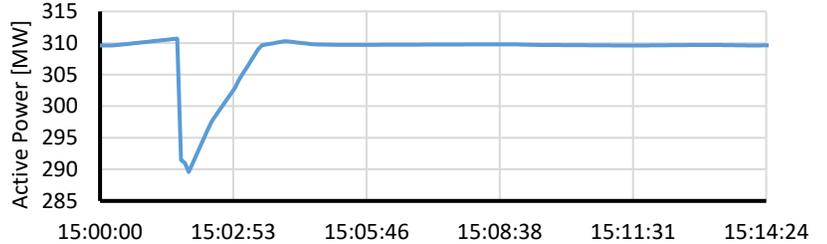
**Plant T**

The plant reduced power output by 21 MW and increased reactive power output by nine MVAR. However, the ramp back to predisturbance output is about one minute 45 seconds, indicating plant-level controller interactions are hindering inverter recovery of active power after the fault.

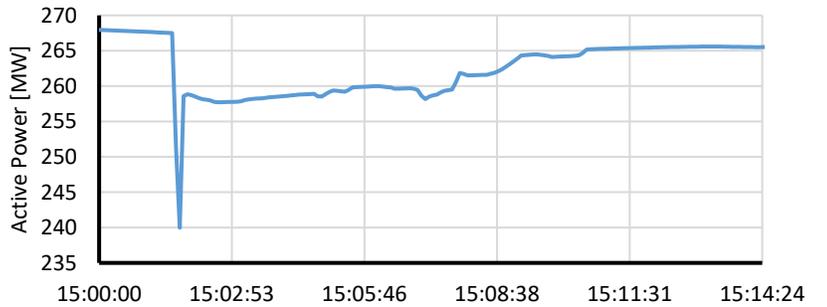
**Plant U**

The plant reduced power output by 28 MW and increased reactive power output by seven MVAR. However, the ramp back to predisturbance output took over nine minutes. Three inverters are suspected of tripping; however, fault code records were not recoverable by the plant owner.

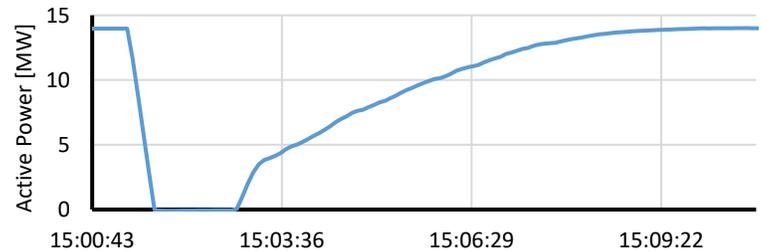
### Plant AD

All inverters tripped on instantaneous ac overcurrent protection at 110% of peak nominal value. The plant returned to full power output in about nine minutes.

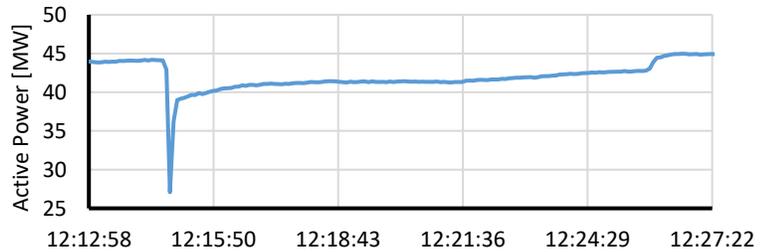
**Plant A**

Three inverters tripped on ac overcurrent protection set at 150% of rated current. Inverters at the facility also entered momentary cessation.

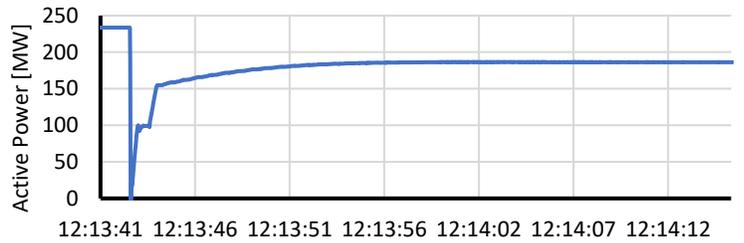
**Plant D**

This plant includes legacy inverters with momentary cessation enabled at 0.875 pu voltage, 1,020 ms delay to recover, and 8.2%/sec ramp rate to restore active power output. Forty-one inverters tripped on dc overcurrent protection.

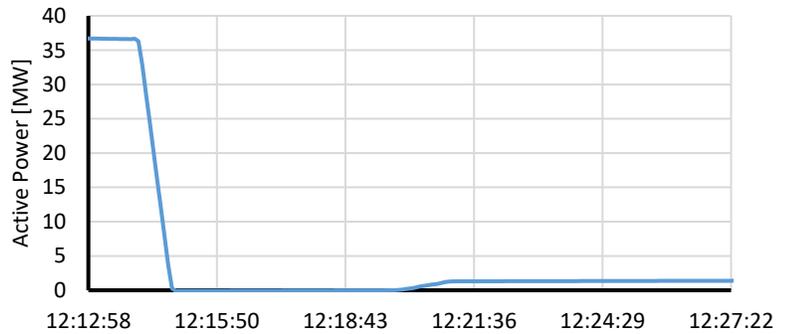
**Plant E**

The plant owner stated that all inverters at the facility tripped for the following reasons: instantaneous ac overvoltage, short time ac undervoltage, grid undervoltage, PLL loss of synchronism, grid overfrequency, and voltage phase jump. The plant owner was unable to provide additional details as to which fault code tripped each inverter. One inverter restored output in five minutes; the remaining inverters required manual restart.

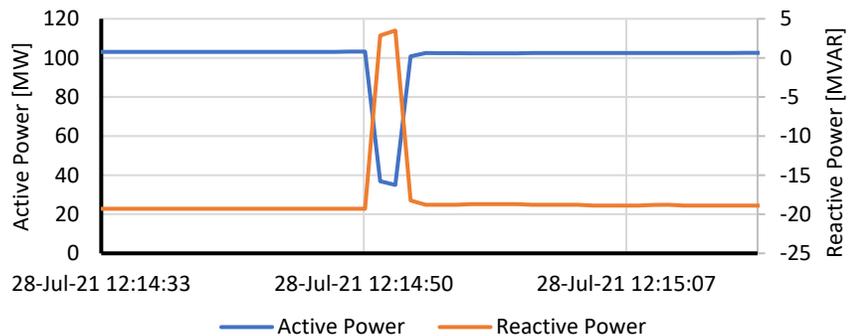
**Plant F**

Inverters provided reactive power support during the fault; however, they sacrificed active power output, which required about four seconds to recover. This recovery is relatively quick but still longer than recommendations from NERC reliability guidelines.

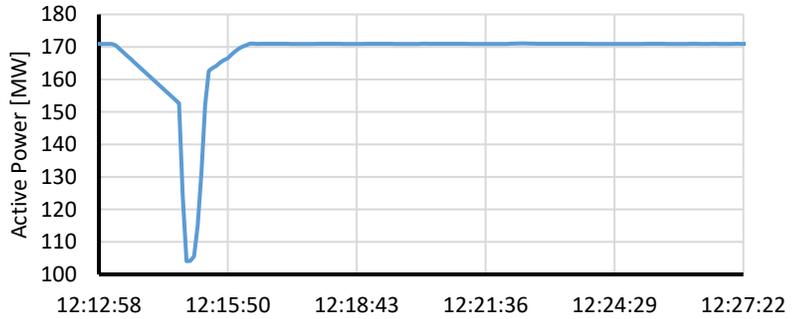
**Plant J**

Multiple inverters tripped on instantaneous ac overvoltage at their terminals exceeding 1.3 pu. Those inverters returned to service automatically after a few minutes. Plant SCADA data was stored with five-minute resolution and therefore limited information was available to further understand the plant response to the event.

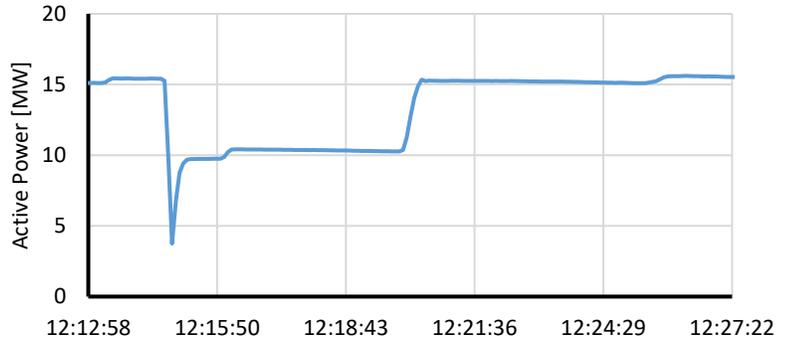
**Plant O**

Eighteen inverters tripped on “fast ac minimum voltage percent for greater than 10 cycles (adjustable)” and restored output automatically five minutes later. The remaining inverters entered momentary cessation; settings are unknown for this plant. It was stated by the plant owner that inverter performance for the remaining inverters that did not trip “is not available due to SCADA communications failure” at the time of the event. Furthermore, it was stated that many of the inverters had no fault information because “the buffer capture clears the data when the auto-restart triggers.” This plant is configured in a way where data is not being properly stored to capture any information for event analysis.

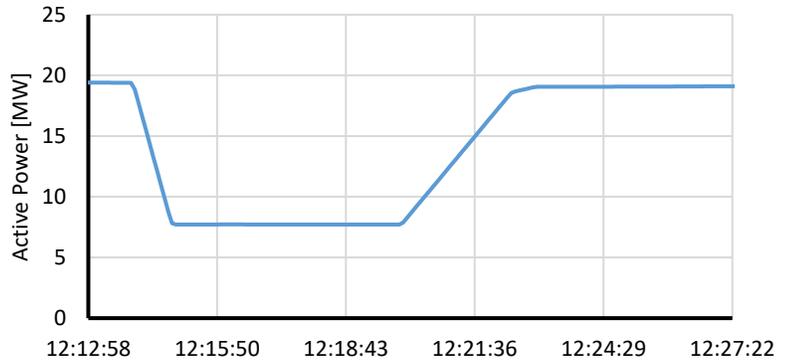
**Plant S**

The cause of reduction is unknown. The plant was unable to provide any useful information in response to the RFI nor during follow-up requests for additional information. The plant highlighted that they were waiting on additional information from the inverter manufacturer but were ultimately unable to provide any useable information for root cause analysis. The shape of the reduction and recovery is indicative of inverter tripping with automatic reconnection.

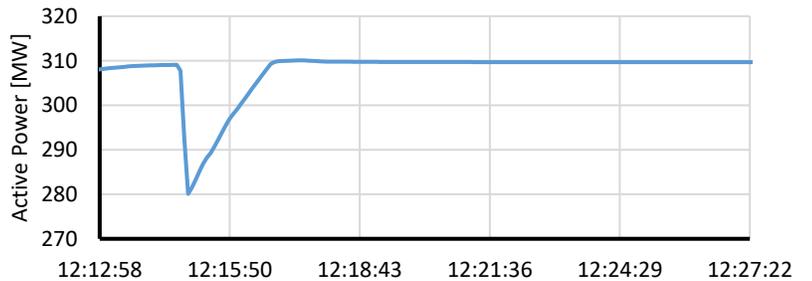
**Plant T**

The plant reduced power output by 39 MW and increased reactive power output by 14 MVAR. However, the ramp back to predisturbance output is about 2 minutes and 15 seconds, indicating plant-level controller interactions.

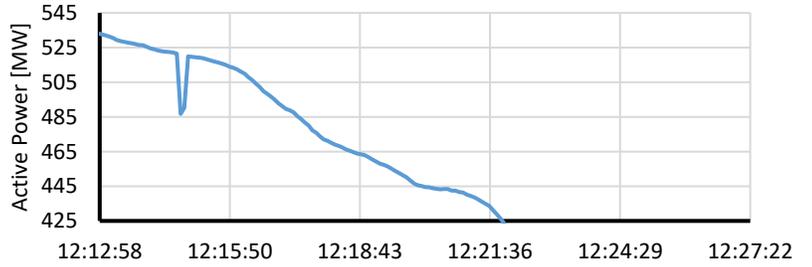
**Plant X**

The plant responded dynamically to the fault, reducing active power by 34 MW and returned to predisturbance output in about 15 seconds. This does not meet the recommended performance specified in NERC reliability guidelines.

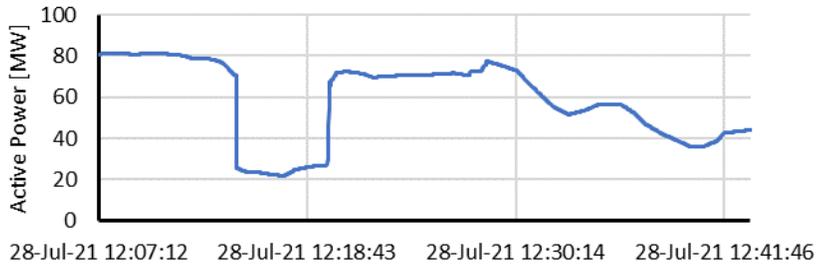
**Plant Y**

Fifteen inverters tripped on measured overfrequency caused by a very fast trip setting of 61.7 Hz for 1 ms. Two inverters tripped on ac low voltage, but the plant owner was unable to identify trip thresholds.

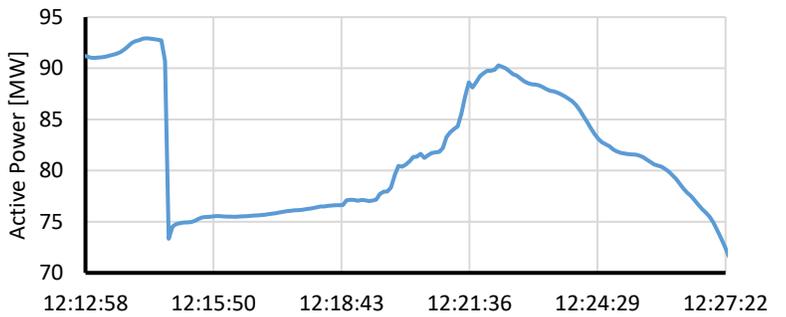
**Plant AC**

All on-line inverters entered momentary cessation for roughly 33 ms during the fault. Thirty-one inverters returned to service immediately while five inverters tripped on “unbalanced voltage” conditions.

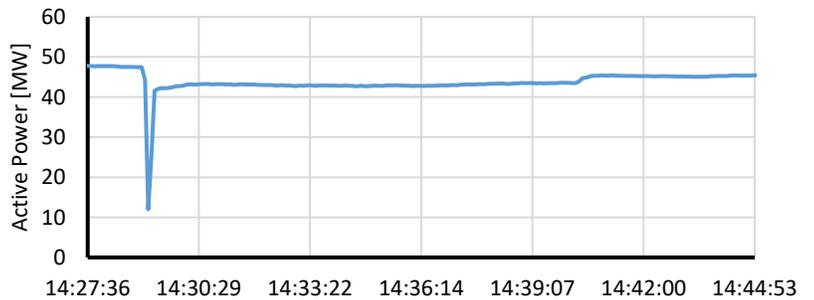
**Plant A**

One inverter tripped on instantaneous ac overcurrent above 150% of rated current and two inverters tripped with no fault code recorded. The remaining inverters entered momentary cessation (configured with 0.9 pu voltage threshold, a 0.1 second time delay to recover, and no defined ramp rate upon recovery).

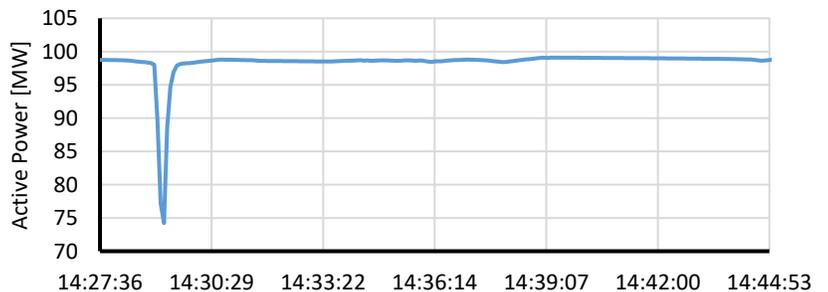
**Plant B**

The plant dynamically responded to the fault; however, active power recovery took about 40 seconds, which does not meet the recommended performance specified in NERC reliability guidelines.

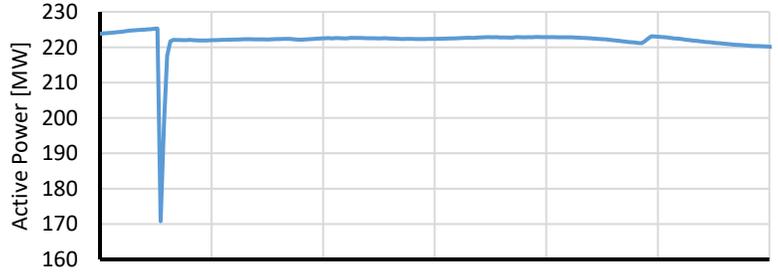
**Plant D**

This plant includes legacy inverters with momentary cessation enabled at 0.875 pu voltage, 1,020 ms delay to recover, and 8.2%/sec ramp rate to restore active power output. Two inverters tripped on dc overcurrent protection, and four inverters tripped on ac overcurrent protection.

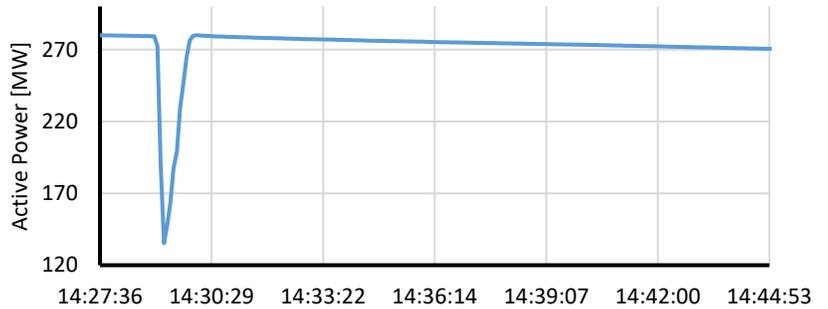
**Plant G**

Legacy inverters entered momentary cessation, and some minor plant controller interactions slightly inhibited recovery of active power to predisturbance output levels.

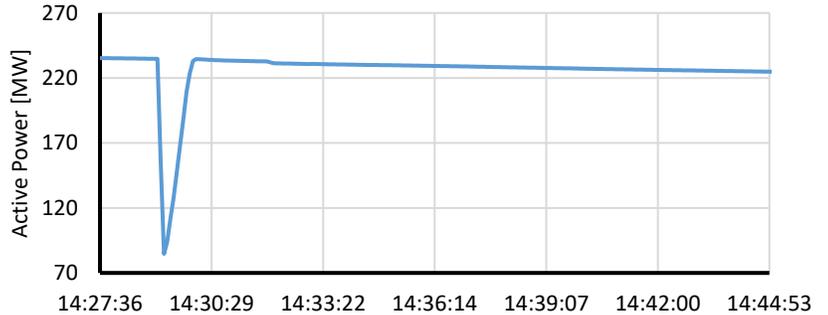
**Plant H**

Legacy inverters entered momentary cessation, and some minor plant controller interactions slightly inhibited recover of active power to predisturbance output levels.

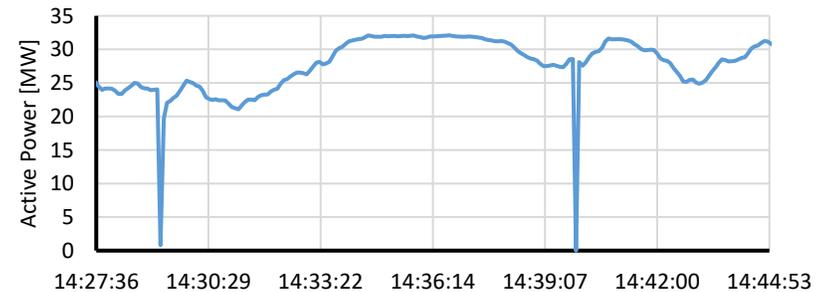
**Plant I**

Two inverters tripped on instantaneous ac overcurrent above 150% of rated current and one tripped with no fault code recorded. The remaining inverters entered momentary cessation (configured with 0.9 pu voltage threshold, a 0.1 second time delay to recover, and no defined ramp rate upon recovery).

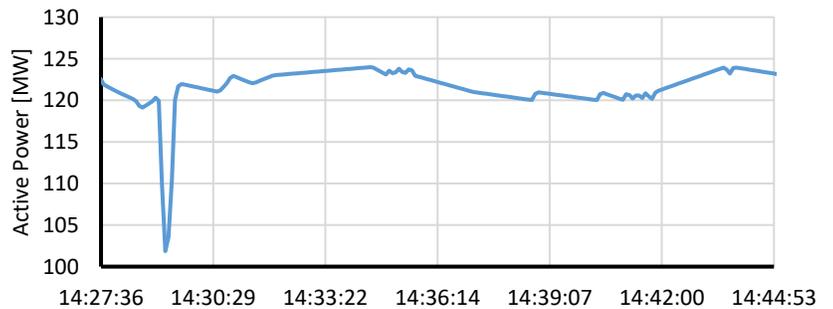
**Plant P**

The plant dynamically responded to the fault and recovered active power in about 25 seconds. No inverters tripped or entered momentary cessation. The delayed recovery does not meet the recommended performance specified in NERC reliability guidelines.

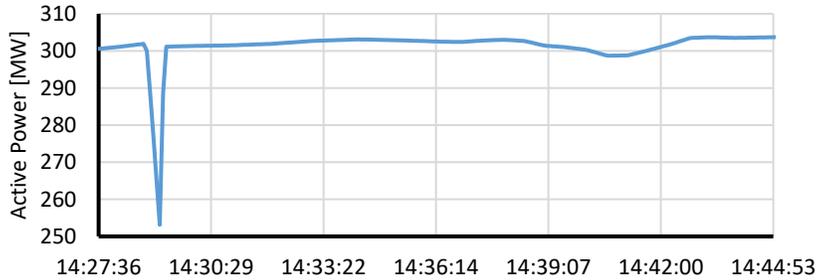
**Plant T**

The plant dynamically responded to the fault and recovered active power in about 30 seconds. No inverters tripped or entered momentary cessation. The delayed recovery does not meet the recommended performance specified in NERC reliability guidelines.

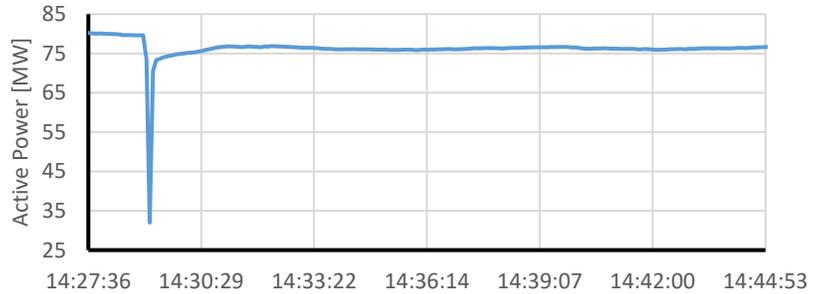
**Plant U**

Two inverters tripped on instantaneous ac overcurrent above 150% of rated current and one with no fault code recorded. Other inverters entered momentary cessation (configured with 0.9 pu voltage threshold, a 0.1 second time delay to recover, and no defined ramp rate upon recovery).

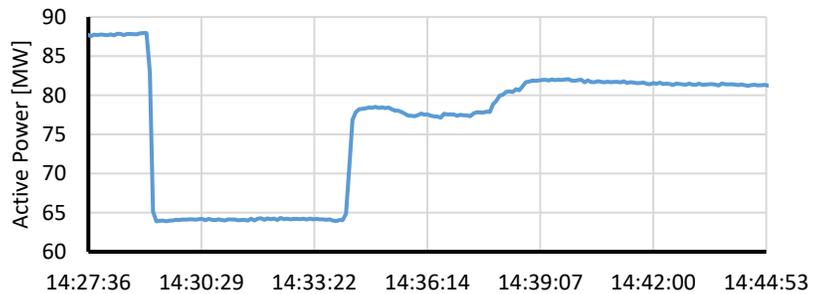
**Plant Y**

Six inverters tripped on overfrequency, and two inverters reported “all modules have stopped” with no additional details, and one inverter tripped on “voltage unbalance” between the high and low side of the dc bus. The inverters that tripped on overfrequency protection have trip settings of 61.7 Hz for 1 ms.

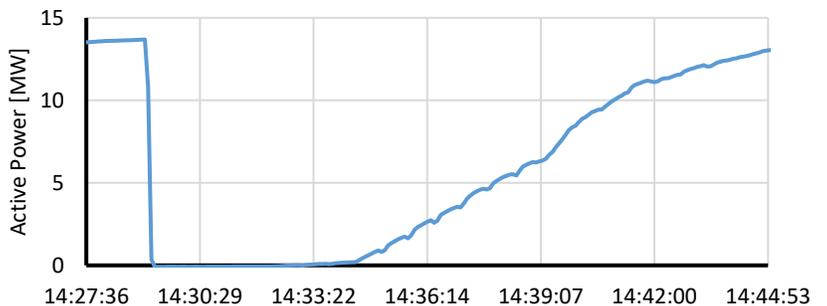
**Plant Z**

This plant reduced output to zero (by about 14 MW) for five minutes and then slowly ramped back to predisturbance levels by about 15 minutes after the fault. WECC requested contact information for this non-BES facility from CAISO; however, CAISO was unable to provide contact information because the plant was undergoing a change of ownership and had yet to provide the required documentation. Therefore, WECC and NERC were unable to perform any analysis on this facility; the cause of reduction is unknown.

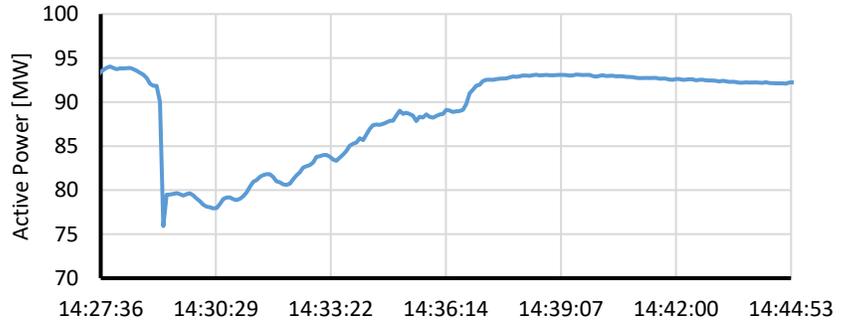
**Plant AC**

All inverters entered into momentary cessation at the time of the fault. Inverter voltage ride-through settings were “disabled allowing momentary cessation to occur.” This issue was corrected on September 1, 2021 and momentary cessation was subsequently disabled. The plant response to the event shows a significantly delayed recovery of about seven minutes back to predisturbance output levels.

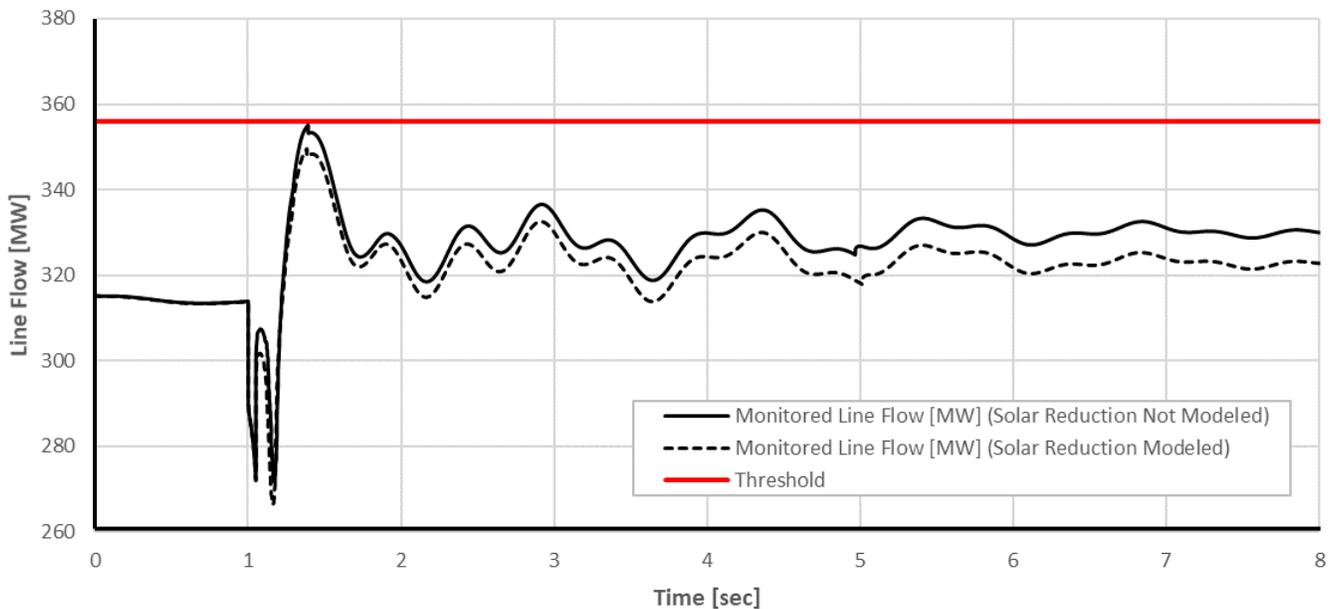
**Figure C.1: Simulation of RAS Operation with and without Solar PV Modeled**

- **Unexpected/Unplanned RAS Operation:** A natural gas turbine tripped carrying 212 MW when a 220 kV line exceeded a RAS threshold. The RAS initiated a trip function to the generator during the power swing immediately upon fault clearing.
- **Combustion Turbine Tripping:** A natural gas turbine tripped while carrying 91 MW. This generator is not associated with the RAS described above. This unit tripped due to excitation system failure (failed diodes) that occurred at the time of the event. While the diodes are redundant, a failure can only be identified by manual inspection and was undetected prior to the event. Therefore, the response of the unit to the fault event likely led to the failure of the second diode, and the unit ultimately tripped. The plant has increased their inspection rate to avoid this issue in the future.

The RAS that operated is located about 130 circuit-miles from the fault location, illustrating how a centralized fault in a well-connected location can have far-reaching impacts on protection and controls of both generating assets and transmission assets. The RAS monitors three conditions involving two thermal overloads and a bus voltage and initiates generator tripping for monitored thermal overload conditions. The thermal overload arming point for the RAS uses phase instantaneous overcurrent elements on the monitored 220 kV lines set at a certain current threshold (i.e., the rating of the line). If the overload is detected, the RAS issues a trip signal to a combustion turbine generator within 15 cycles.

SCE conducted a simulation of system operating conditions to analyze the contributing cause of the RAS operation (see [Figure C.1](#)). As the figure shows, the power swings reach very close (simulations do not exactly match actual system conditions) to the trip threshold<sup>44</sup> immediately after the fault that occurred around 130 circuit miles away.
