# Panhandle Wind Disturbance

Texas Event: March 22, 2022  
Joint NERC and Texas RE Staff Report

August 2022

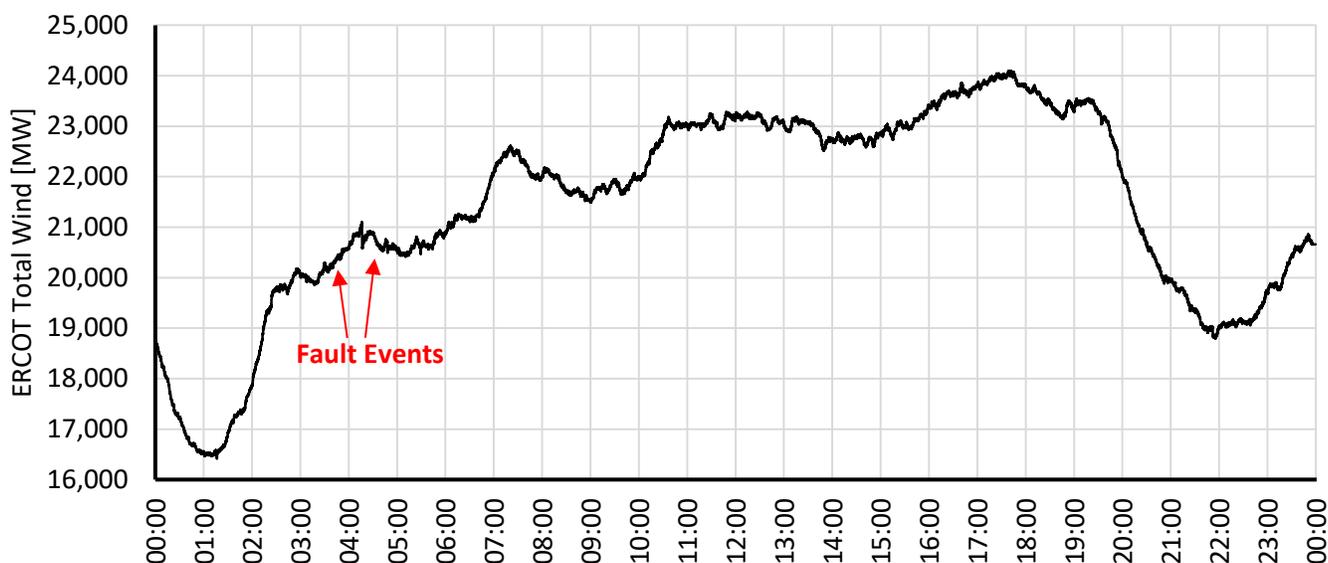
Figure I.1: ERCOT Total Wind Profile for March 22, 2022

[Figure I.1](#) shows the total ERCOT wind power profile for March 22, 2022, as well as the times of the faults. The disturbance is visible in the total wind output plot; however, the magnitude of reduction is not the primary operational concern for this report; the unexpected reduction of power output across multiple wind plants is the primary focus of this analysis. All of the affected facilities were located in the Texas Panhandle area. The affected facilities included turbines and controllers from three different wind manufacturers.

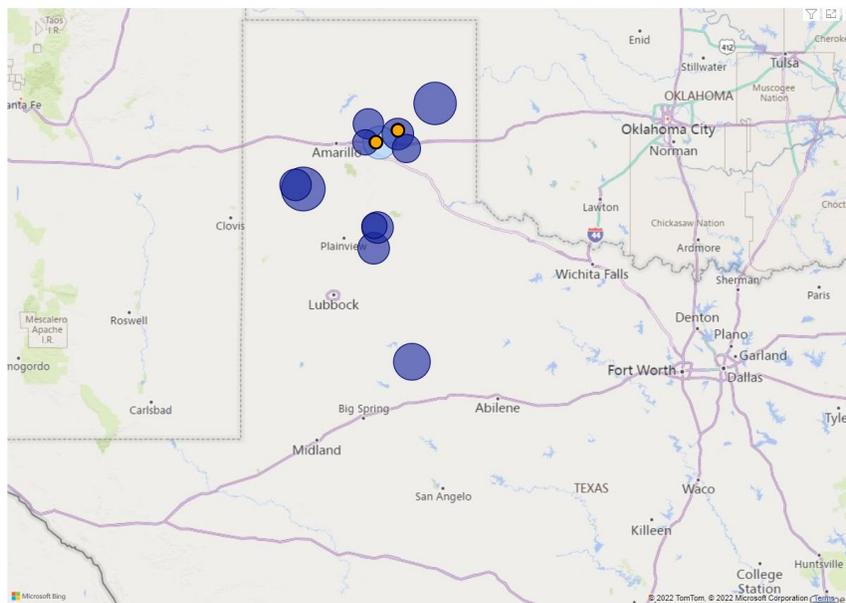
**Figure I.4: Map of the Fault Location and Affected Facilities**

The faults occurred in the Panhandle area of the ERCOT footprint. Figure I.4 shows the geographic location of the faults (orange), the wind plants that tripped (light blue), and other affected wind facilities that responded abnormally (dark blue). The circle size illustrates the magnitude of reduction. Wind plants identified as abnormally responding to the event were located up to about 170 miles away from the fault location.

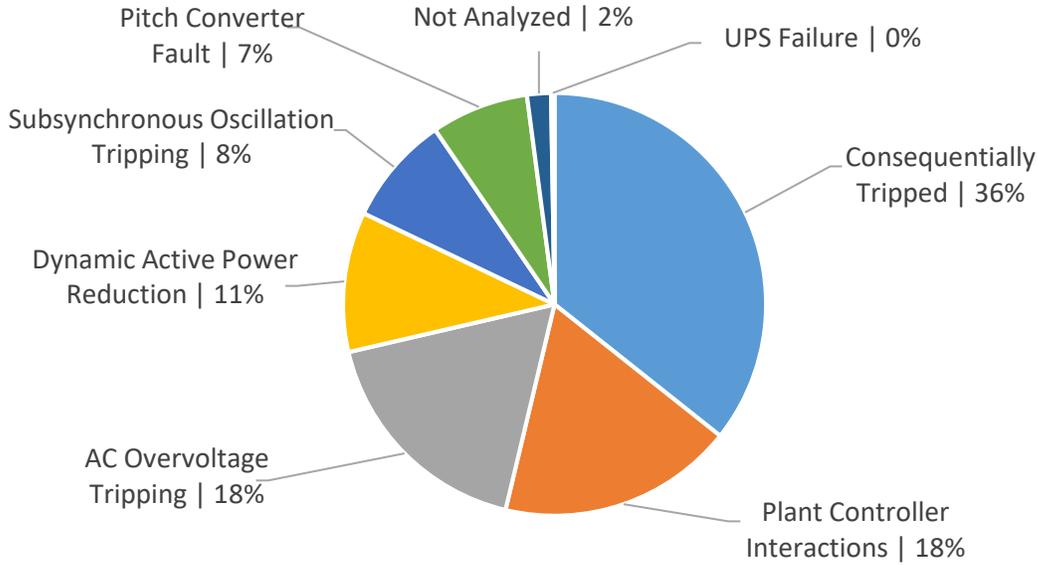
**Figure 1.1: Causes of Wind Plant Reduction for Fault 1**

[Table 1.1](#) show the causes and magnitudes of active power reduction in each March 2022 fault event. The consequential (second fault) tripping of wind resources was the largest reduction in output, but this was expected due to the first fault. The next most common reduction involved plant controller interactions impeding the ability of the plant to return to predisturbance output levels. AC overvoltage tripping at one facility also tripped a significant number of inverters. Dynamic active power reductions caused by the fault also were a notable cause of reduction. One plant tripped on detected subsynchronous oscillation tripping for both faults, and multiple facilities also tripped due to errors in their pitch converters. One plant had one turbine trip on failed uninterruptible power supply, and one plant was not analyzed in detail. [Figure 1.1](#) and [Figure 1.2](#) show a graphical representation of this information.

Table 1.1: Causes of Reduction for Fault 1 and Fault 2		
Cause of Reduction	Fault 1 Reduction [MW]	Fault 2 Reduction [MW]
Consequentially Tripped	273	–
Plant Controller Interactions	138	144
AC Overvoltage Tripping	135	64
Dynamic Active Power Reduction	82	128
Subsynchronous Oscillation Tripping	64	55
Pitch Converter Faults	57	17
Not Analyzed	14	–
Uninterruptible Power Supply Failure	2	–

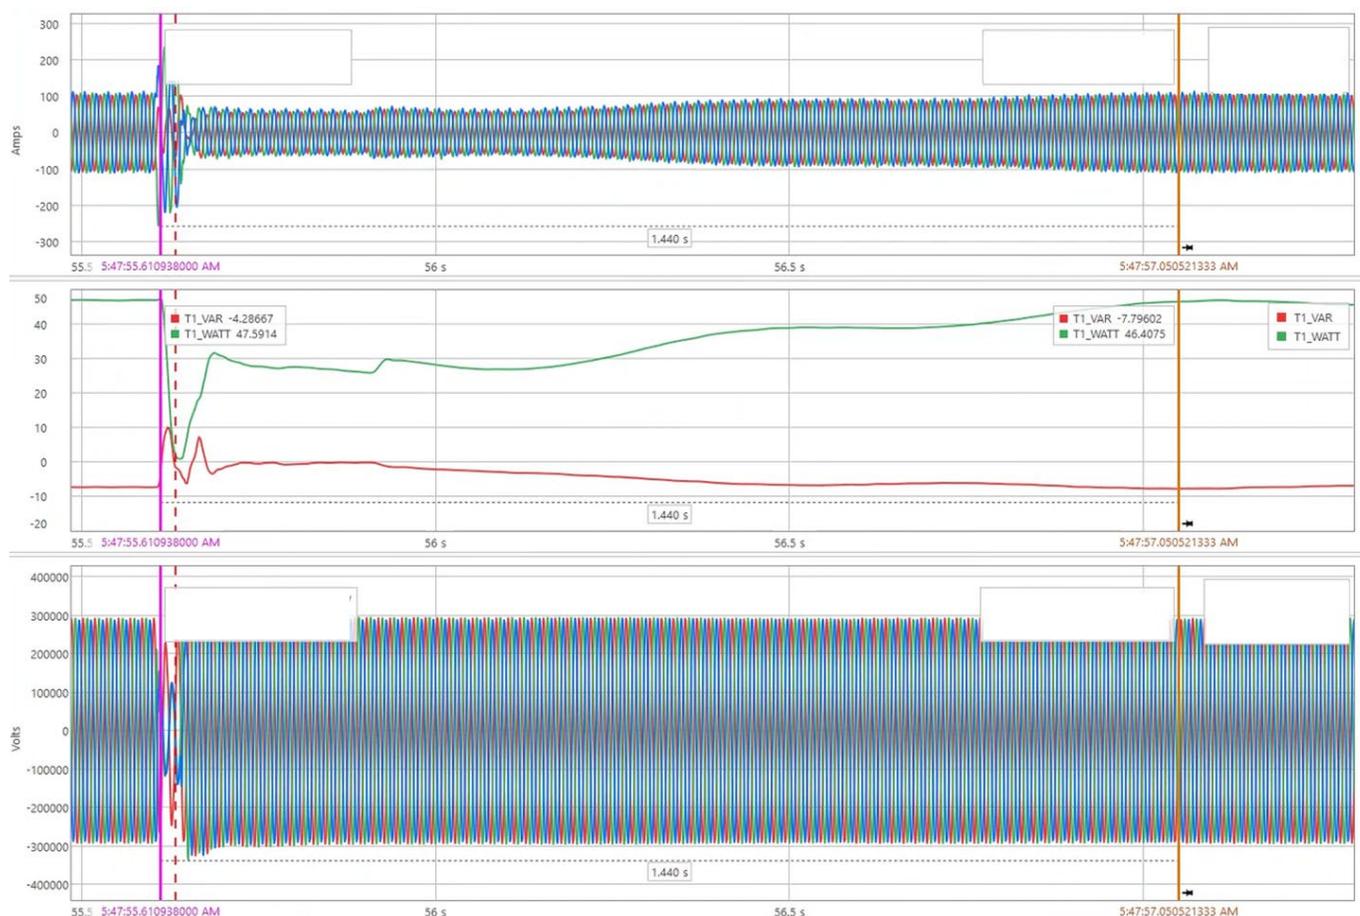
**Figure 1.5: Dynamic Response of Plant to Second Fault**

The relatively significant reduction in active power is often caught by SCADA data depending on scan rates. **Figure 1.4** shows an example of a plant that reduced output for both the first and second fault with active power dropping to near zero and recovering very quickly. SCADA data essentially missed the first fault and only picked up a partial reduction for the second fault. **Figure 1.5** shows the high speed oscillography data capturing the plant going to zero output during the fault and recovering over a time period of 1–1.5 seconds.

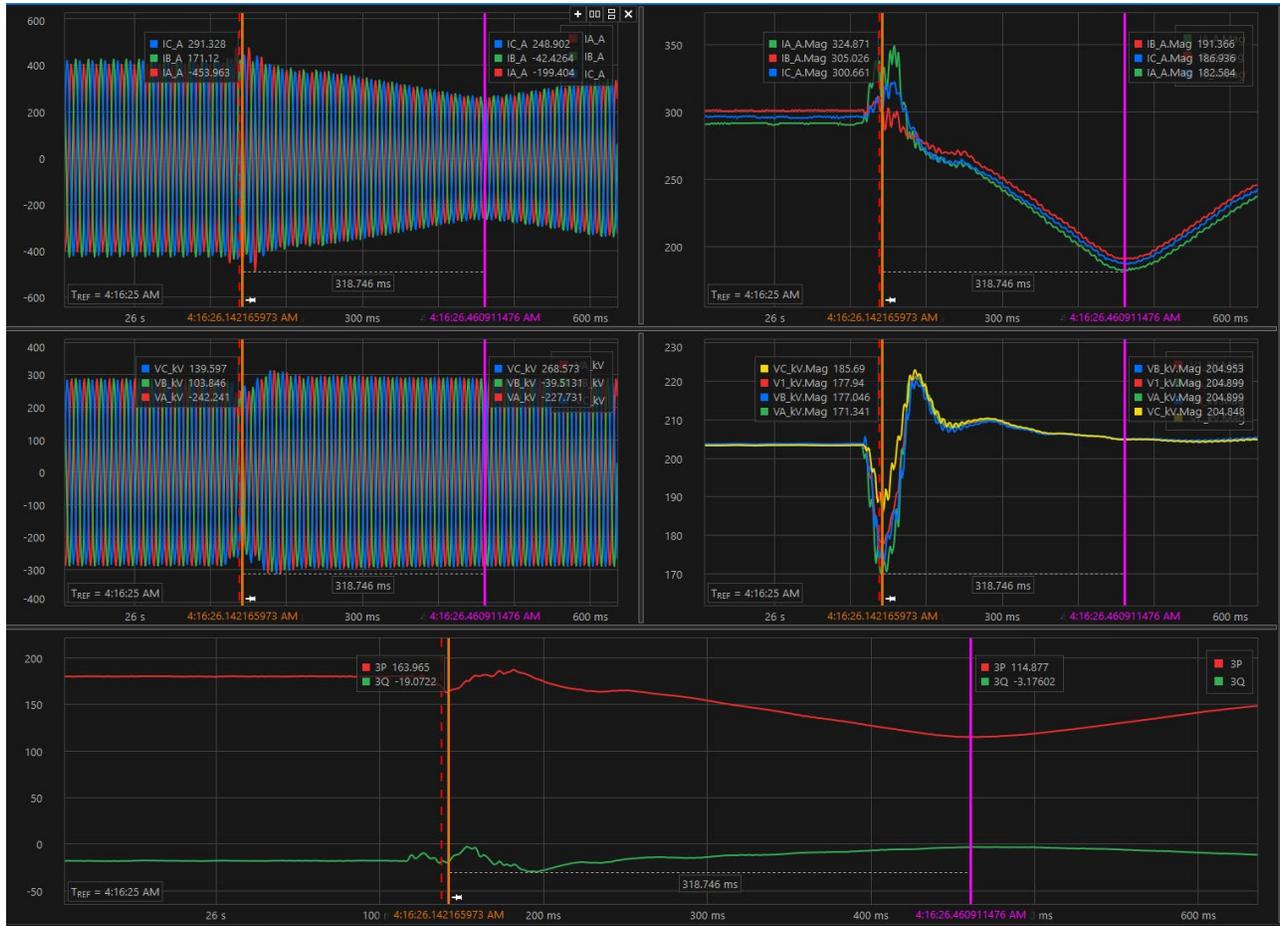
**Figure 1.6: Plant Dynamic Response before Plant Controller Interactions**

Multiple plants from different manufacturers had plant controller interactions that resulted in an abnormal post-fault active power recovery to predisturbance output levels. The issue stems from the fact that these faults, which are not uncommon, caused plant voltage to go low (i.e., the turbines enter into low voltage ride-through (LVRT) mode) but the frequency also declined due to the loss of resources. When the LVRT condition occurs, the plant controller pauses and cedes control to the individual turbines. Once voltage recovers post-fault clearing, the plant controller regains control and resumes dispatch of the turbines. However, the handoffs between the plant controller and turbines are not properly coordinated.

In the March 2022 disturbance, the plant controller active power-frequency response controls are incorrectly sending dispatch signals to the individual turbines immediately following the LVRT condition; this is partly caused by abnormal or unexpected response of the individual turbines after fault clearing. [Figure 1.6](#) shows one plant where the turbines provide fault current during the low voltage fault; however, turbine current then rapidly decreases post-fault, causing active power output to drop drastically from about 180 MW predisturbance down to a low of 116 MW. During this time, the plant controller is regaining control of the turbines' output and latches on to a plant power output of about 163 MW during the swing. That latched value becomes the new set point dispatch for the active power-frequency controller. So the turbines settle at a new output of 163 MW even though there is sufficient wind speed for 180 MW. Frequency remains low for a couple minutes and the new dispatched set point is held until frequency recovers and the erroneous dispatch from the controller is released. Once frequency returns to near nominal, the plant rapidly recovers back to predisturbance output (see [Figure 1.7](#)).

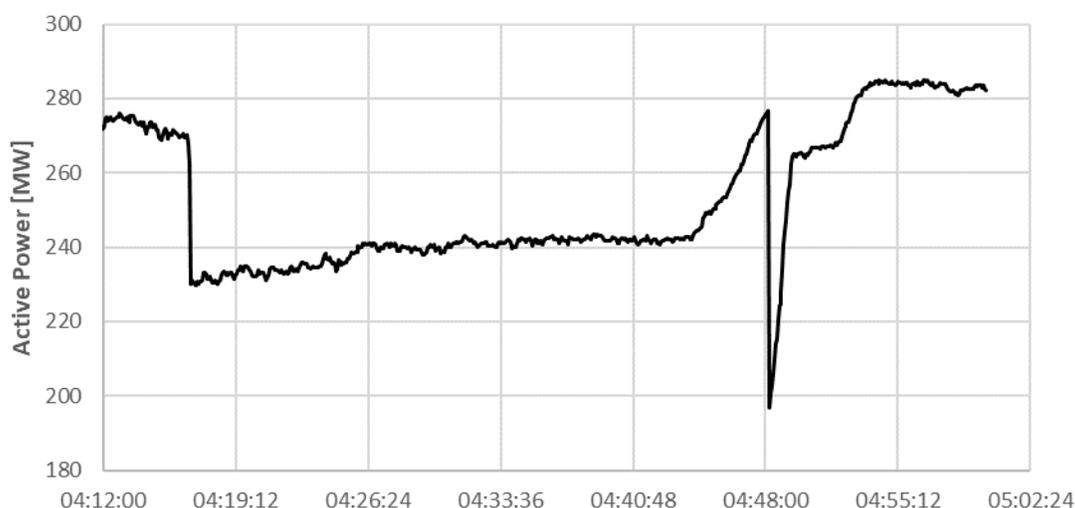
**Figure A.3: Plant Active and Reactive Power Output**

The GO has requested the turbine manufacturer to investigate the cause of pitch converter faults further, and those investigations are presently ongoing; no modifications have been made to the facility to mitigate this issue moving forward. The GO stated that they have reviewed relevant NERC guidelines and alerts and are in discussions with the OEM to potentially implement additional recommendations; however, a time line for additional performance improvements is yet to be determined. The plant owner stated that these specific pitch faults are not applicable to modeling activities conducted by TPs and PCs, so they are not included in any dynamic models (EMT or positive sequence) and no changes are being made to the models.

The analysis team also requested details regarding why the responses look significantly different; however, the plant owner was unable to provide any additional details regarding this question.

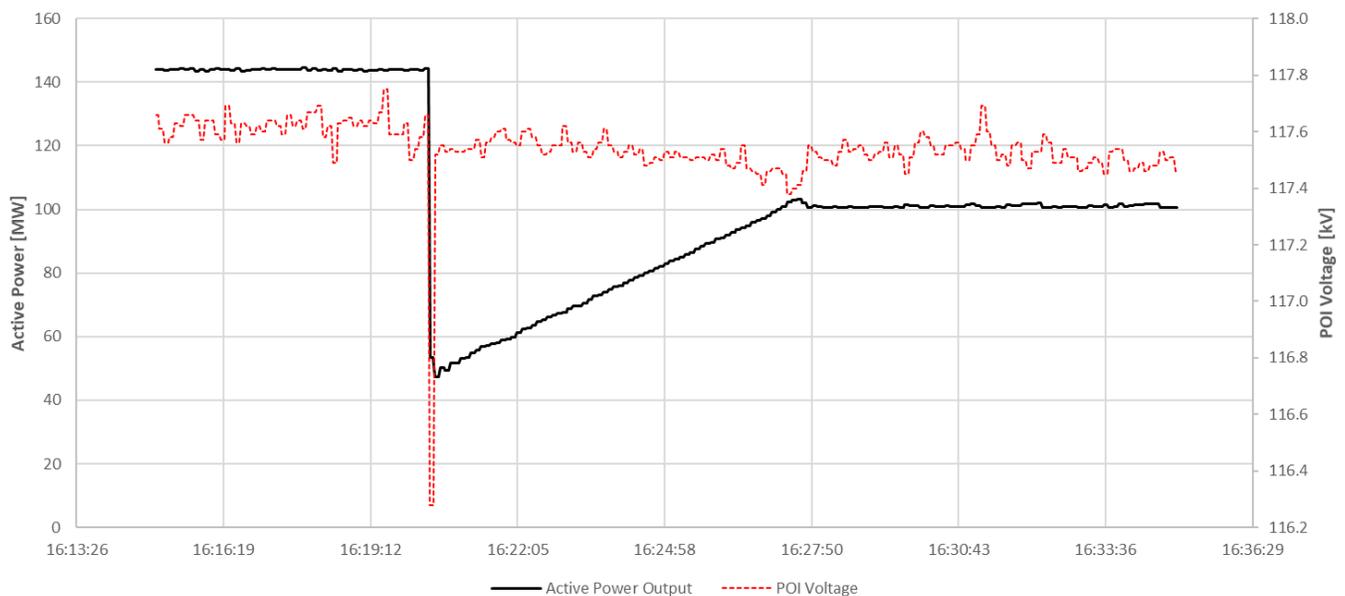
**Figure B.1: Overall Wind Plant Response to BPS Fault**

**Figure B.2** shows high resolution oscillography data at the POI and shows the response of the plant around the time of the fault. When the fault occurred, wind turbine current increased (providing fault current), active power dropped slightly, and reactive power increased; this is the expected response of a wind turbine to a BPS fault. However, towards the time of fault clearing, active power rapidly dropped to 0 MW and remained at that level for a prolonged period of time after voltage has returned to nominal. The wind plant controls dictated the response of the plant, and these controls were not performing in an expected or reliable manner. This type of information is also not captured in the lower-resolution SCADA data shown in **Figure B.1** and would be otherwise unknown if this data were not available.

NERC recommended the TOP work with the facility owner to seek corrective actions in collaboration with the equipment manufacturer.

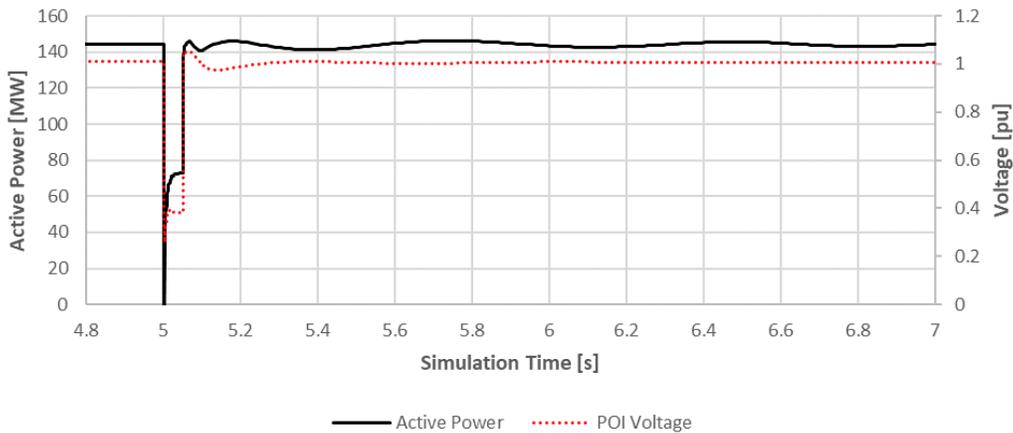
**Figure B.3: High Speed Oscillography Data at POI Showing Plant Response to Fault**

NERC recreated a reflective simulation of this event in a positive sequence dynamic simulation platform and applied a three-phase fault for three cycles at a BPS bus in the vicinity of the wind plant. The goal was not to recreate the event exactly (as this was an unbalanced fault) but rather to observe similarities or differences between the modeled and actual response of the plant. In the simulation, voltage drops to about 0.4 pu during the fault and then recovers after fault clearing. The plant power output drops to zero at the onset of the fault and recovers to about 75 MW by the time the fault has cleared. After clearing the fault, active power recovered back to predisturbance levels within 0.1 seconds. **Figure B.3** shows the simulation results; this simulation illustrates that the post-fault response of the wind plant during actual operation is not the intended or expected response per what was modeled in the interconnection study process nor what was reported for the facility’s model verification testing.<sup>22</sup> As expected, the plant controller interactions are also not represented in the dynamic models. Therefore, this plant is operating in an unreliable manner with plant performance that does not match the reliability studies conducted prior to allowing the plant to connect to the grid. Corrective actions should be taken immediately at this facility to address these issues.
