900 MW Fault Induced Solar Photovoltaic Resource Interruption Disturbance Report

Southern California Event: October 9, 2017
Joint NERC and WECC Staff Report

February 2018

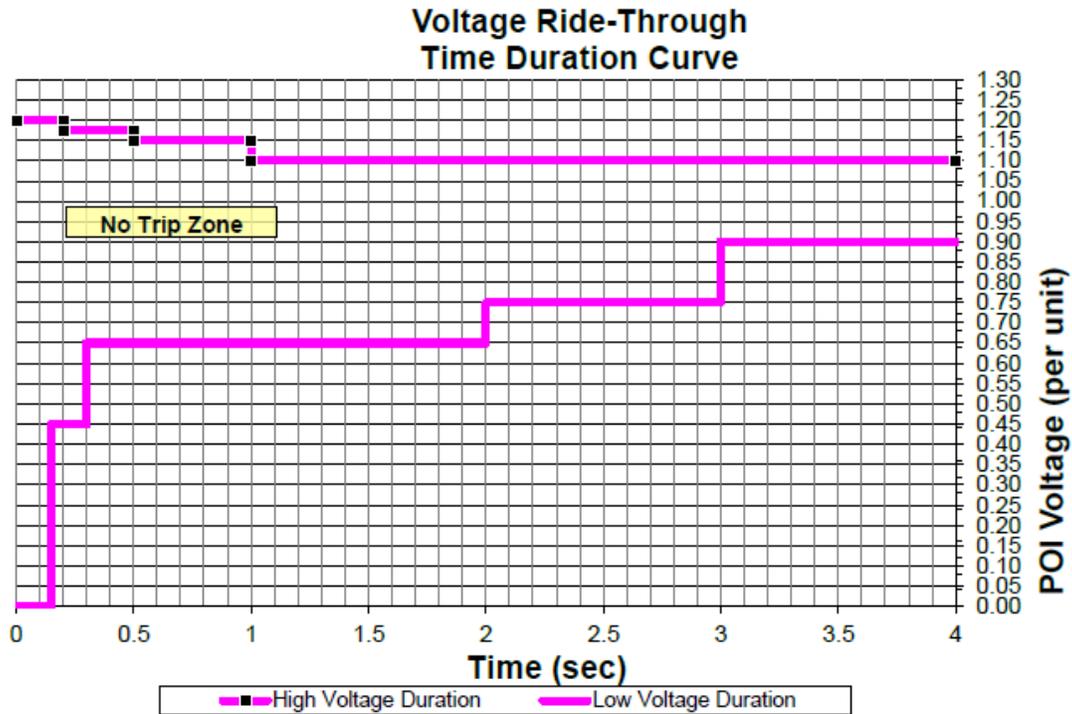
Figure 2.2: PRC-024-2 Voltage Ride-Through Curve

All responses from the data request sent after the October 9, 2017, disturbance indicated that the PRC-024-2 voltage ride-through curve (see Figure 2.2 and Table 2.1) was used to set the voltage protective relay settings for inverters installed on the BPS. Some responses also indicated that the “may trip” zone is still interpreted as a “must trip” zone, despite the attempt in the Blue Cut Fire disturbance report to clarify the intent of PRC-024-2.

The PRC-024-2 ride-through curve is often used as the inverter voltage protection trip settings by default rather than considering equipment limitations to set the protective thresholds. The intent of the PRC-024-2 curve is not to specify a design criteria for resources. Rather, inverter protection settings should be based on the equipment specifications that may be wider than those of the PRC-024-2 curve. The IRPTF is investigating in simulations the potential impacts of all inverters in a geographical or electrical region tripping during voltage transients.

The intent of PRC-024-2 is to define the minimum and maximum voltage conditions where generating resources may trip for voltage excursions. The region outside the “no trip” zone should be interpreted as a “may trip” zone and not a “must trip” zone. Inverter settings should be determined based on equipment limitations and should be set to ride-through to the greatest extent possible. This helps support BPS reliability during and following grid events such as faults.

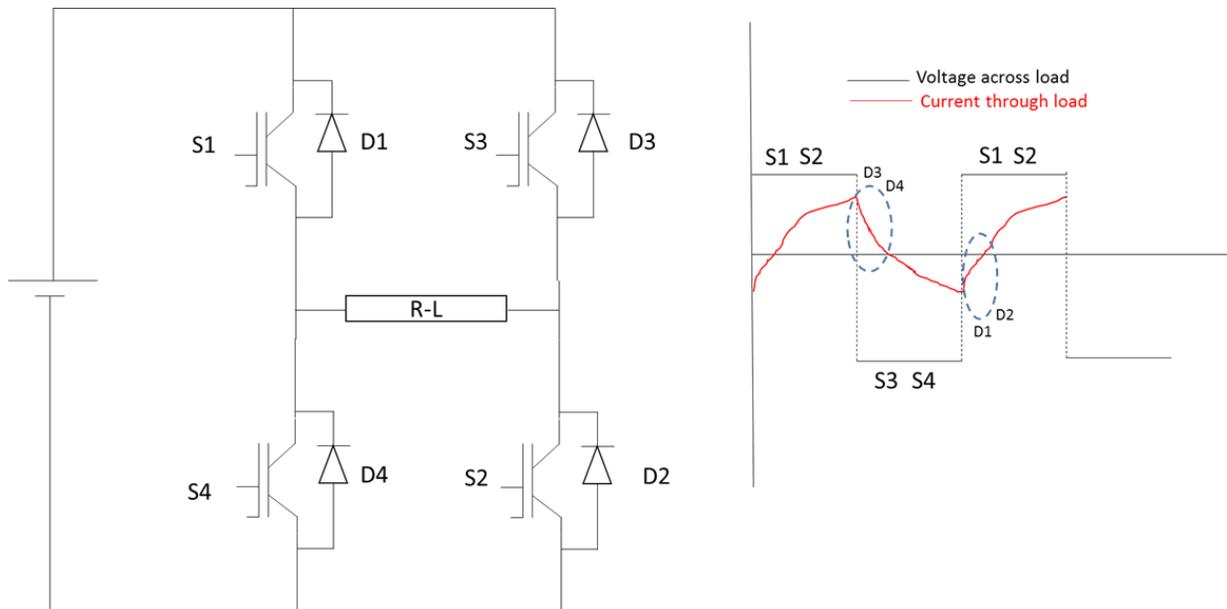
Figure 2.5: Online Illustration of Anti-Parallel Diodes

One inverter manufacturer reported fault codes for dc reverse current, where protective action opened the inverter primary circuit breaker. The dc reverse current is considered a “major fault” by that manufacturer that requires a manual reset at the inverter. This resulted in the resources remaining off-line for an average of 81 minutes after tripping.

Inverters have anti-parallel diodes across the insulated-gate bipolar transistors (IGBTs), or switches in the power electronics (see illustration in Figure 2.5), to mitigate voltage spikes during switching. For inductive loads, like loads across the BPS, current through the inductor cannot change instantly otherwise transient voltage spikes occur. The anti-parallel diodes are used to allow current through the inductive load to go to zero. For example, when switches S1 and S2 are on, current flows left to right in the R-L load. When the half cycle is over, S1 and S2 turn off and S3 and S4 turn on. During this time, energy is fed back to the dc bus. During normal operation, this is a small amount of reverse current and is acceptable. During normal operation, the inverter is generating an ac waveform from the dc voltage through IGBT gating. This process necessitates the inverter to balance the ac voltage so as to keep the potential higher on the dc side. Normally this is not a problem; the maximum ac voltage the inverter can generate is sufficiently lower than the field dc voltage, thus current can flow out to the grid. However, ac transient over-voltages may cause the ac voltage to be greater than the dc voltage. This can lead to current flowing into the dc bus and PV arrays.

UL Std. 1741¹⁵ includes a testing requirement that any reverse current should not exceed the manufacturer's specification for maximum reverse current. The maximum dc reverse current specification here depends on the inverter, and is specified by the manufacturer. However, it does not specify a maximum duration and provides sufficient design flexibility that it should be feasible for inverters to not trip due to reverse current during transient ac over-voltages.
