# 5. How and Why the Blackout Began in Ohio

## Summary

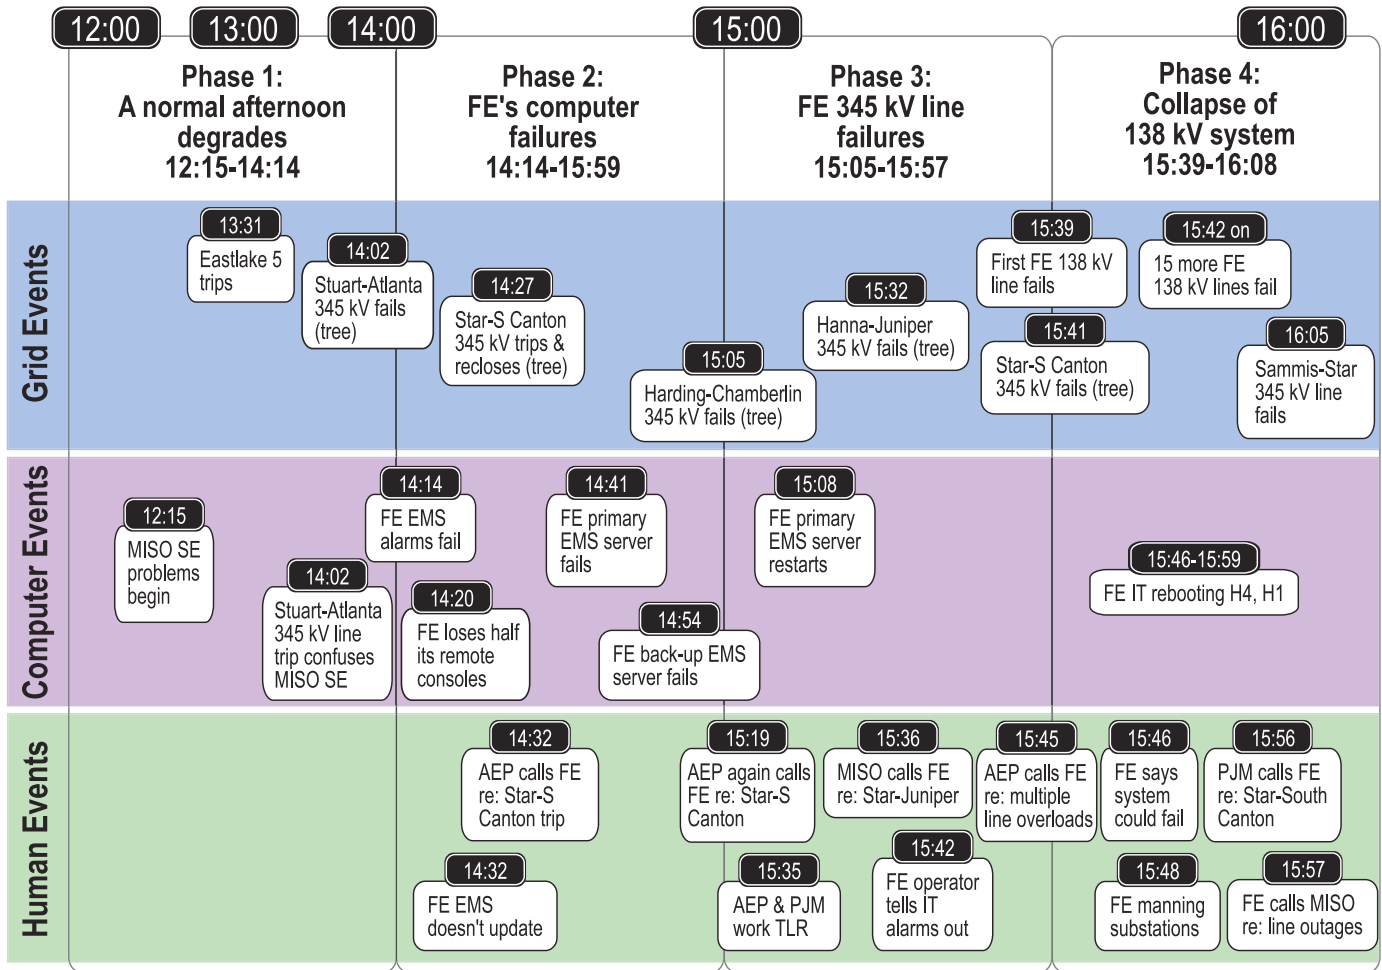
**Figure 5.1. Timeline: Start of the Blackout in Ohio**

Key events within each phase are summarized in Figure 5.1, a timeline of major events in the origin of the blackout in Ohio. The discussion that follows highlights and explains these significant events within each phase and explains how the events were related to one another and to the cascade. Specific causes of the blackout and associated recommendations are identified by icons.

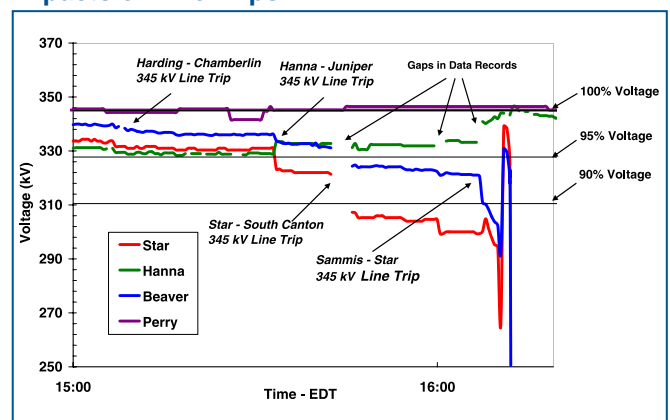
**Figure 5.6. Voltages on FirstEnergy's 345-kV Lines: Impacts of Line Trips**

From 15:05:41 EDT to 15:41:35 EDT, three 345-kV lines failed with power flows at or below each transmission line's emergency rating. These line trips were not random. Rather, each was the result of a contact between a line and a tree that had grown so tall that, over a period of years, it encroached into the required clearance height for the line. As each line failed, its outage increased the loading on the remaining lines (Figure 5.5). As each of the transmission lines failed, and power flows shifted to other transmission paths, voltages on the rest of FE's system degraded further (Figure 5.6).

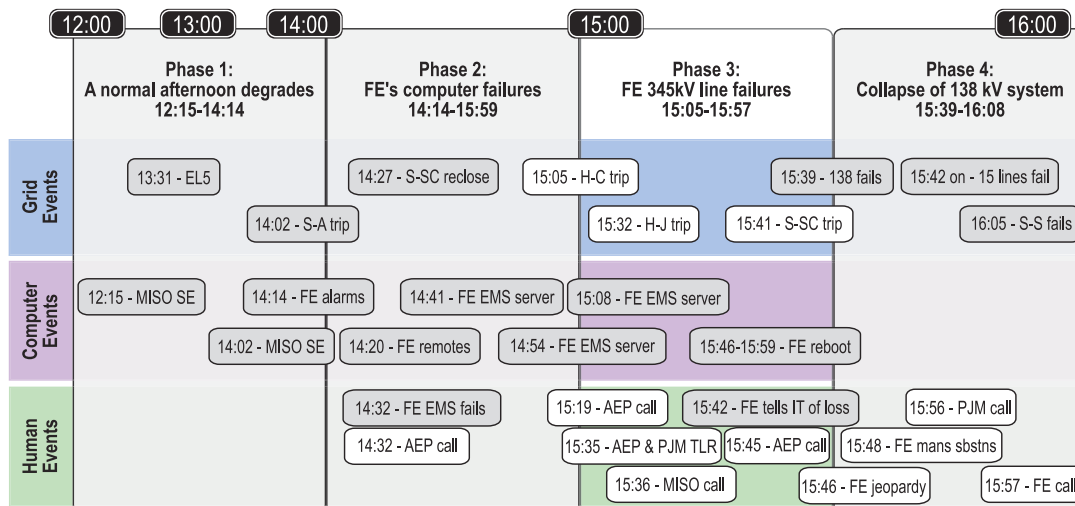
**Figure 5.7. Timeline Phase 3**

contacted a tree three times between 14:27:15 EDT and 15:41:33 EDT, opening and reclosing each time before finally locking out while loaded at 93% of its emergency rating at 15:41:35 EDT. Each of these three lines tripped not because of excessive sag due to overloading or high conductor temperature, but because it hit an overgrown, untrimmed tree.<sup>22</sup>

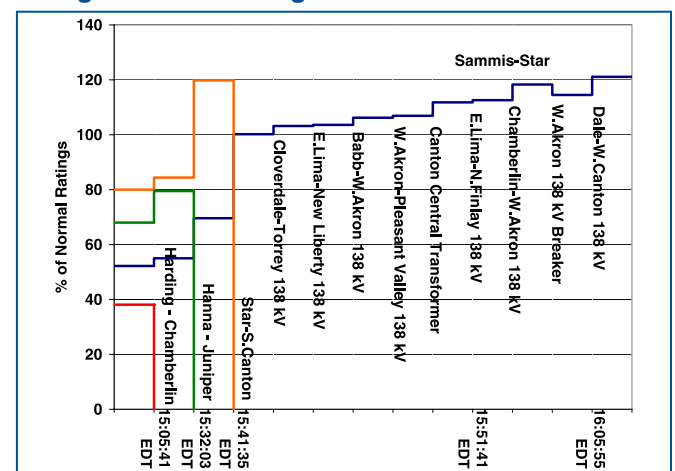
**Figure 5.12. Cumulative Effects of Sequential Outages on Remaining 345-kV Lines**

the loss of the Harding-Chamberlin 345-kV line. Figure 5.12 shows the line loadings estimated by investigation team modeling as the 345-kV lines in northeast Ohio began to trip. Showing line loadings on the 345-kV lines as a percent of normal rating, it tracks how the loading on each line increased as each subsequent 345-kV and 138-kV line tripped out of service between 15:05 EDT (Harding-Chamberlin, the first line above to stair-step down) and 16:06 EDT (Dale-West Canton). As the graph shows, none of the 345- or 138-kV lines exceeded their normal ratings until after the combined trips of Harding-Chamberlin and Hanna-Juniper. But immediately after the second line was lost, Star-South Canton’s loading jumped from an estimated 82% of normal to 120% of normal (which was still below its emergency rating) and remained at the 120% level for 10 minutes before tripping out. To the right, the graph shows the effects of the 138-kV line failures (discussed in the next phase) upon the two remaining 345-kV lines—i.e., Sammis-Star’s loading increased steadily above 100% with each succeeding 138-kV line lost.

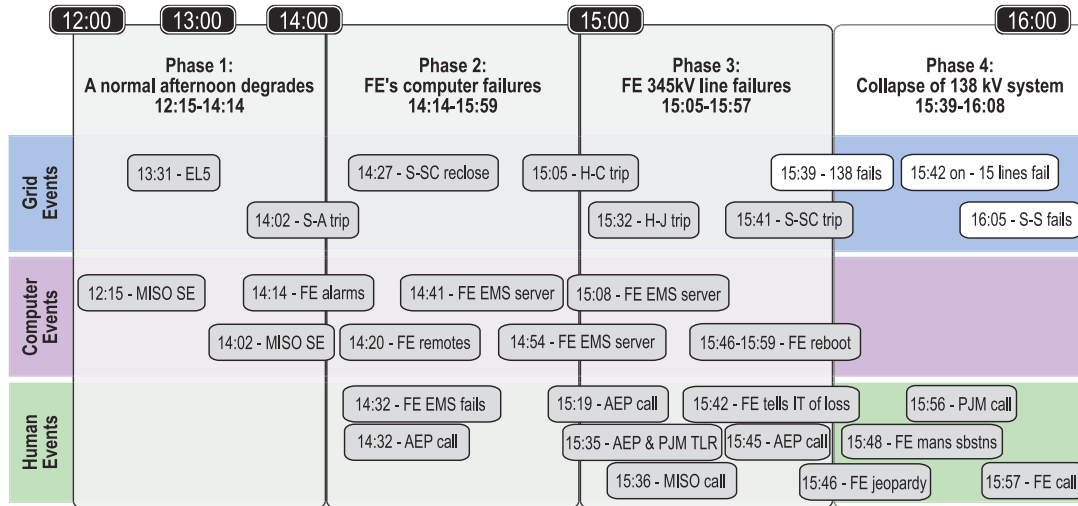
**Figure 5.13. Timeline Phase 4**

As each of FE's 345-kV lines in the Cleveland area tripped out, it increased loading and decreased voltage on the underlying 138-kV system serving Cleveland and Akron, pushing those lines into overload. Starting at 15:39 EDT, the first of an eventual sixteen 138-kV lines began to fail (Figure 5.13). Relay data indicate that each of these lines eventually ground faulted, which indicates that it sagged low enough to contact something below the line.

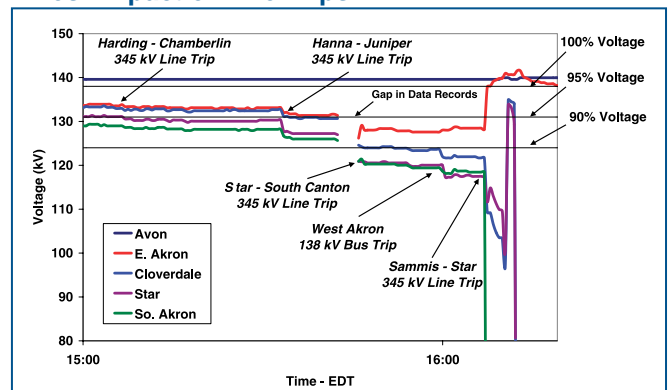
**Figure 5.14. Voltages on FirstEnergy's 138-kV Lines: Impact of Line Trips**

Figure 5.14 shows how actual voltages declined at key 138-kV buses as the 345- and 138-kV lines were lost. As these lines failed, the voltage drops caused a number of large industrial customers with voltage-sensitive equipment to go off-line automatically to protect their operations. As the 138-kV lines opened, they blacked out customers in Akron and the areas west and south of the city, ultimately dropping about 600 MW of load.
