# Arizona-Southern California Outages on September 8, 2011

## Causes and Recommendations

Prepared by the Staffs of the  
Federal Energy Regulatory Commission  
*and the*  
North American Electric Reliability Corporation

**April 2012**

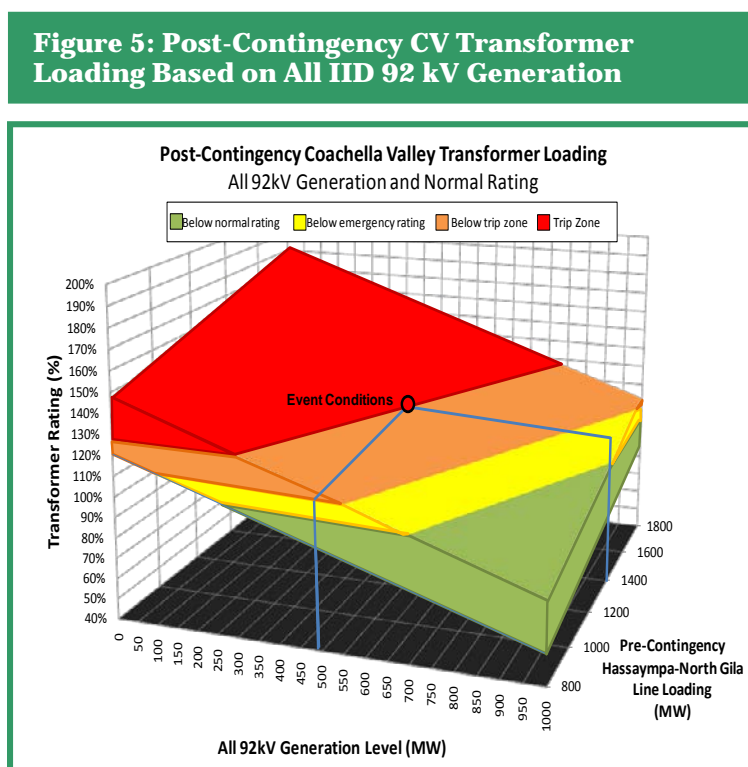
display visible, and RTCA alarms were not audible. By reducing loading on the CV transformers at this pre-event stage, the operator could have mitigated the severe effects on the transformers that resulted when H-NG tripped. Since the event, IID has required, and now requires, its operators to have RTCA results displayed at all times. The loading on IID’s CV transformers was pivotal to this event. Loading on the CV transformers is influenced by: (1) the pre-contingency flow on H-NG; (2) load and generation in IID’s 92 kV network; (3) flow on the S Line; and (4) to a lesser extent, generation connected to the Imperial Valley substation. See Figure 5, below.

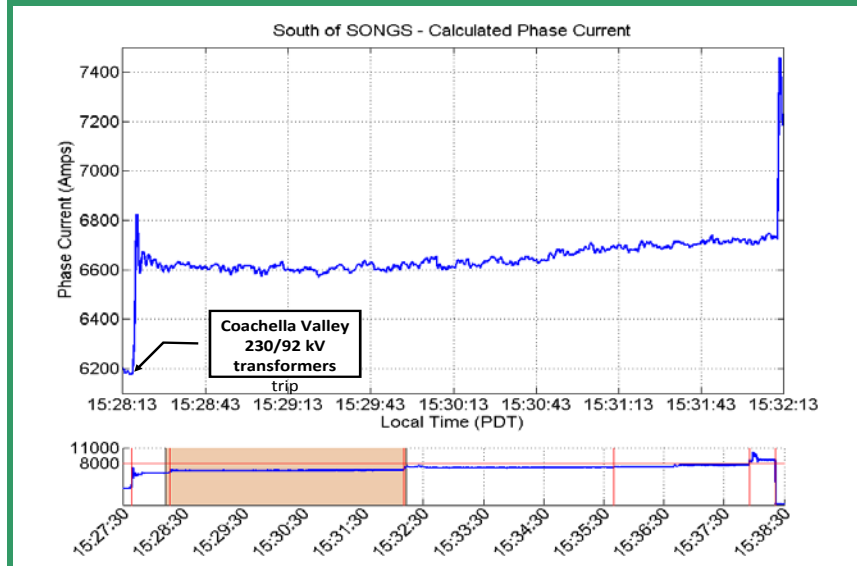
**South of SONGS – Calculated Phase Current**

**15:28:17 – Two Coachella Valley 230/92 kV transformers and the Coachella Valley Ramon 230 kV “KS” line tripped. (030)**

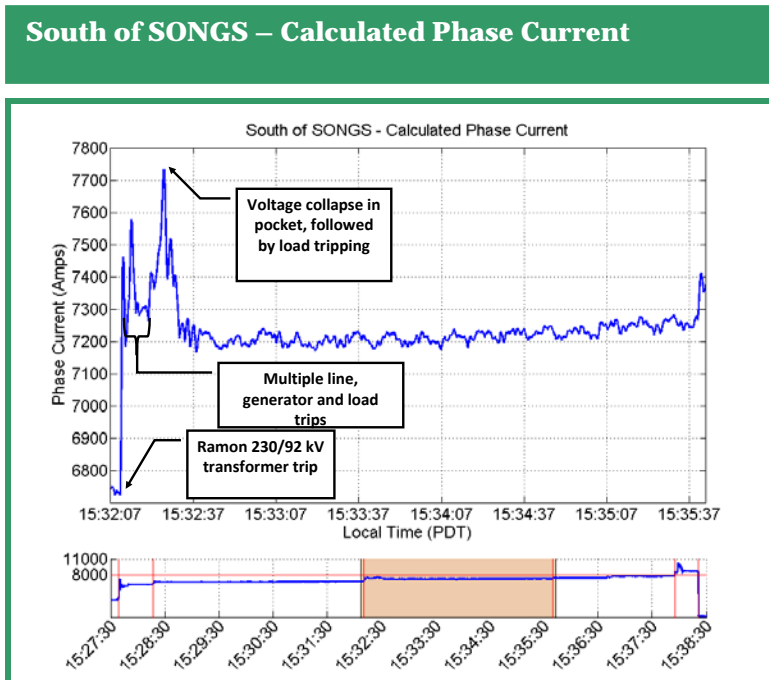
**Time: 15:32:10 – The Ramon 230/92 kV transformer tripped and IID shed 444 MW of load. (110)**

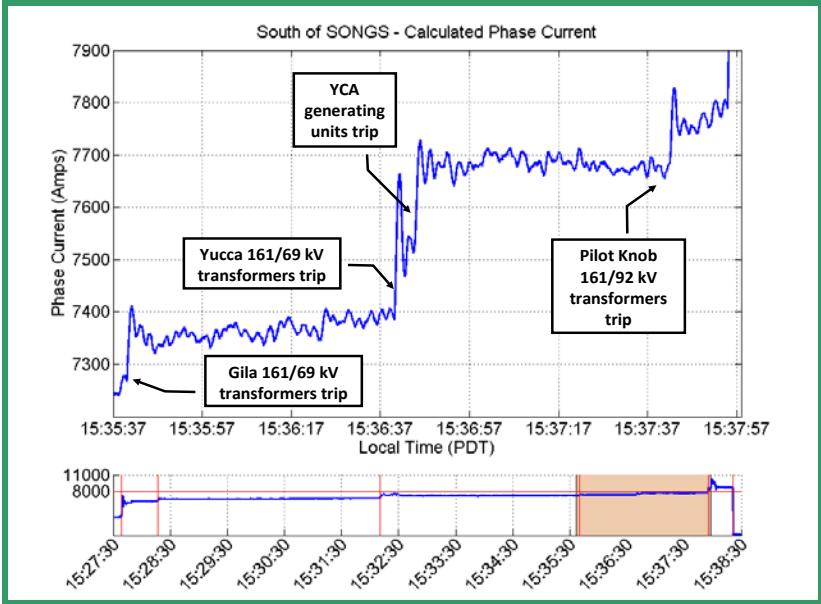
**South of SONGS – Calculated Phase Current**

**Time: 15:35:31 – Yuma Cogen (YCA) tripped. (180)**

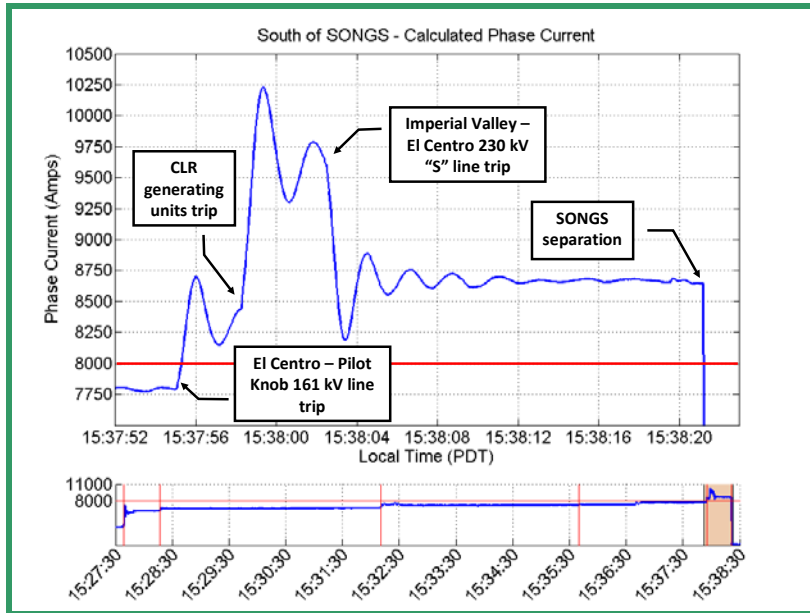
**South of SONGS – Calculated Phase Current**

**Time: 15:37:55 – The El Centro-Pilot Knob 161 kV line tripped. (230)**

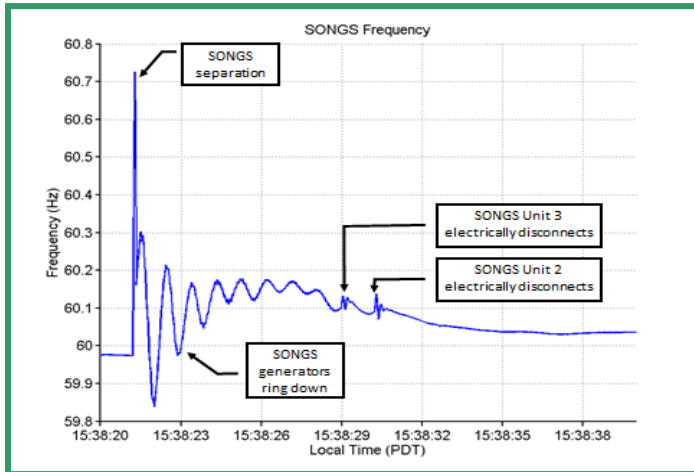
**Figure 12 : Frequency Excursion in WECC Interconnection Immediately after the SONGS**

Loss of the 2,300 MW of SONGS' generation effectively reduced the loss of load for the main body of the Western Interconnection from a 3,400 MW loss to a net 1,100 MW load loss. This made the recovery from the resulting overfrequency event much easier. The SONGS generators did not lose offsite power because the SONGS switchyard was still connected to the SCE system.

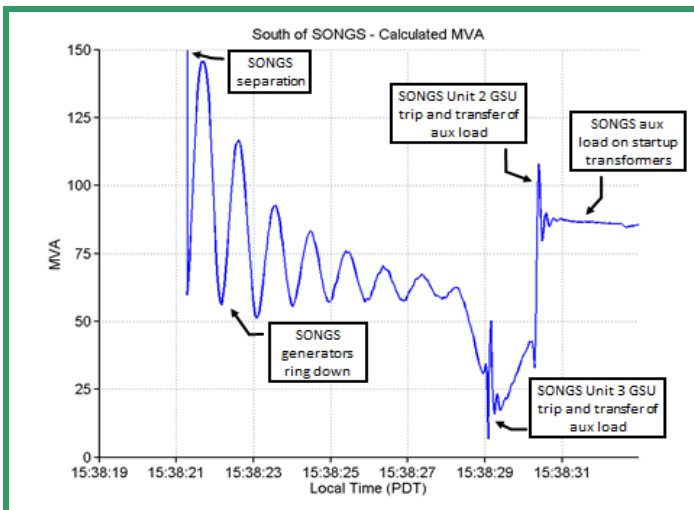
**Figure 13: SONGS Generation Trips and Auxiliary Loads Transfer to 230 kV Bus**

Although the SONGS generators remained connected to the SCE side of the switchyard at SONGS, at about 15:38:27.5, or approximately six seconds after the SONGS separation scheme initiated, the SONGS turbines both experienced a brief acceleration in speed and tripped due to turbine control logic. At the same time, local system frequency at SONGS was observed to spike from 59.974 Hz to 61.203 Hz. After the initial impulse caused by the system separation, the frequency in the main body of the Western Interconnection peaked near 60.170 Hz. This can be seen on Figures 12 and 13, on the next page. The turbine trip initiated a reactor shutdown, and the units began coasting down. A little more than a second later, at 15:38:28.963, SONGS Unit 3 electrically disconnected from the system, and less than three seconds after the reactors shut down, at 15:38:30.209, SONGS Unit 2 electrically disconnected from the system.
