Attachments: 1. NATF Initial Update on HVB 345 kV Breakers, dated December 31, 2013

References: 1. NERC Letter, dated August 27, 2013 – “345 kV HVB Breaker Advisory”

Our attached initial update report details NATF breaker performance history, member past and current actions to address related maintenance advisories, and some considerations for future actions to minimize reliability risks.

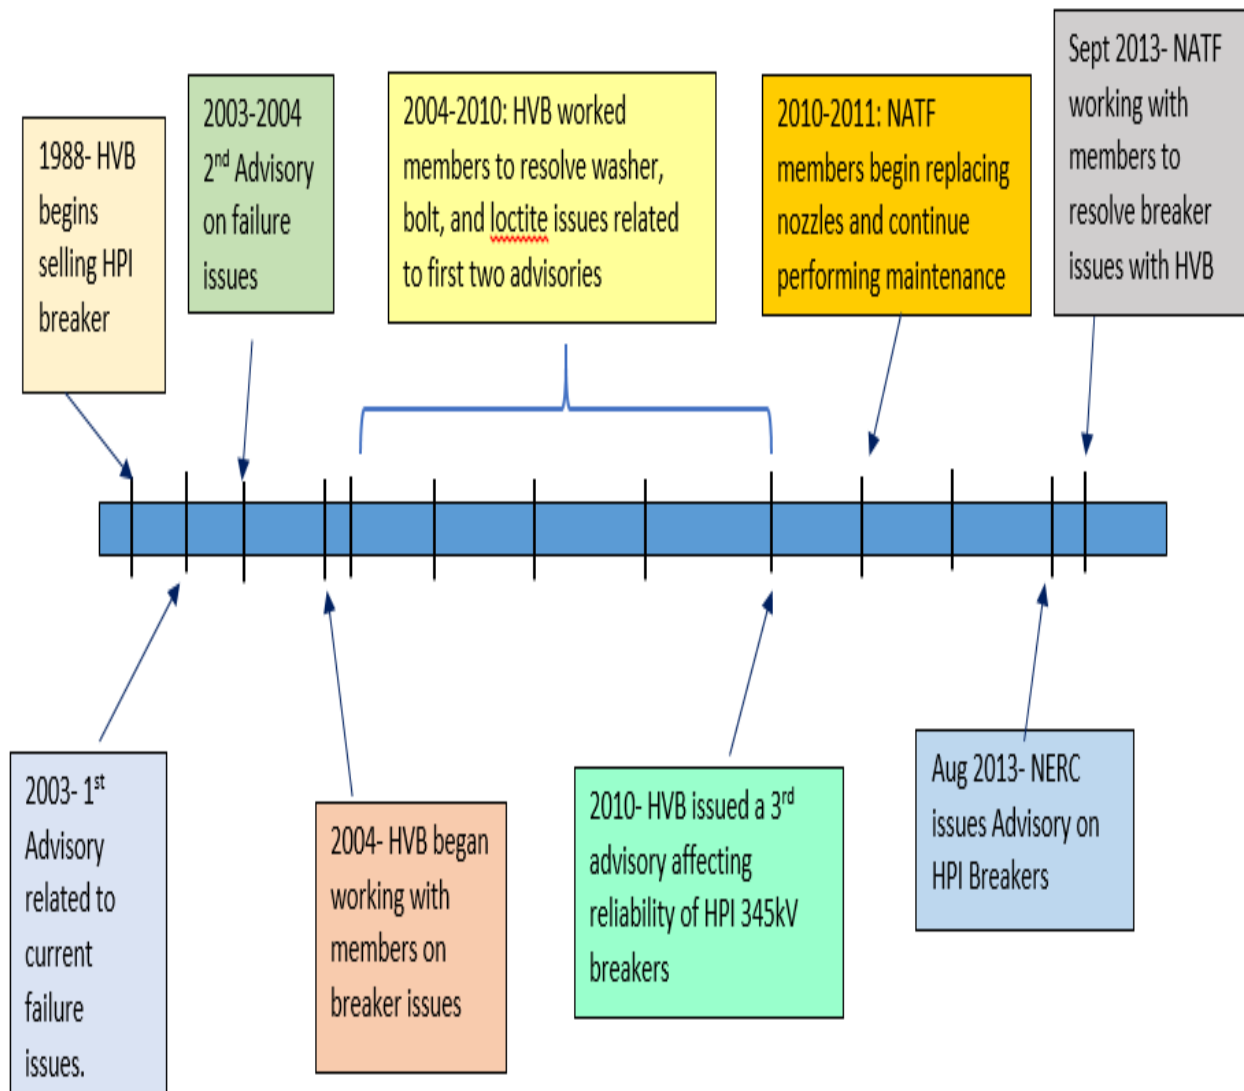
Timeline of 345 kV Breaker Activities with Forum Members

The timelines and charts below provide summary information collected from NATF members and HVB representatives:

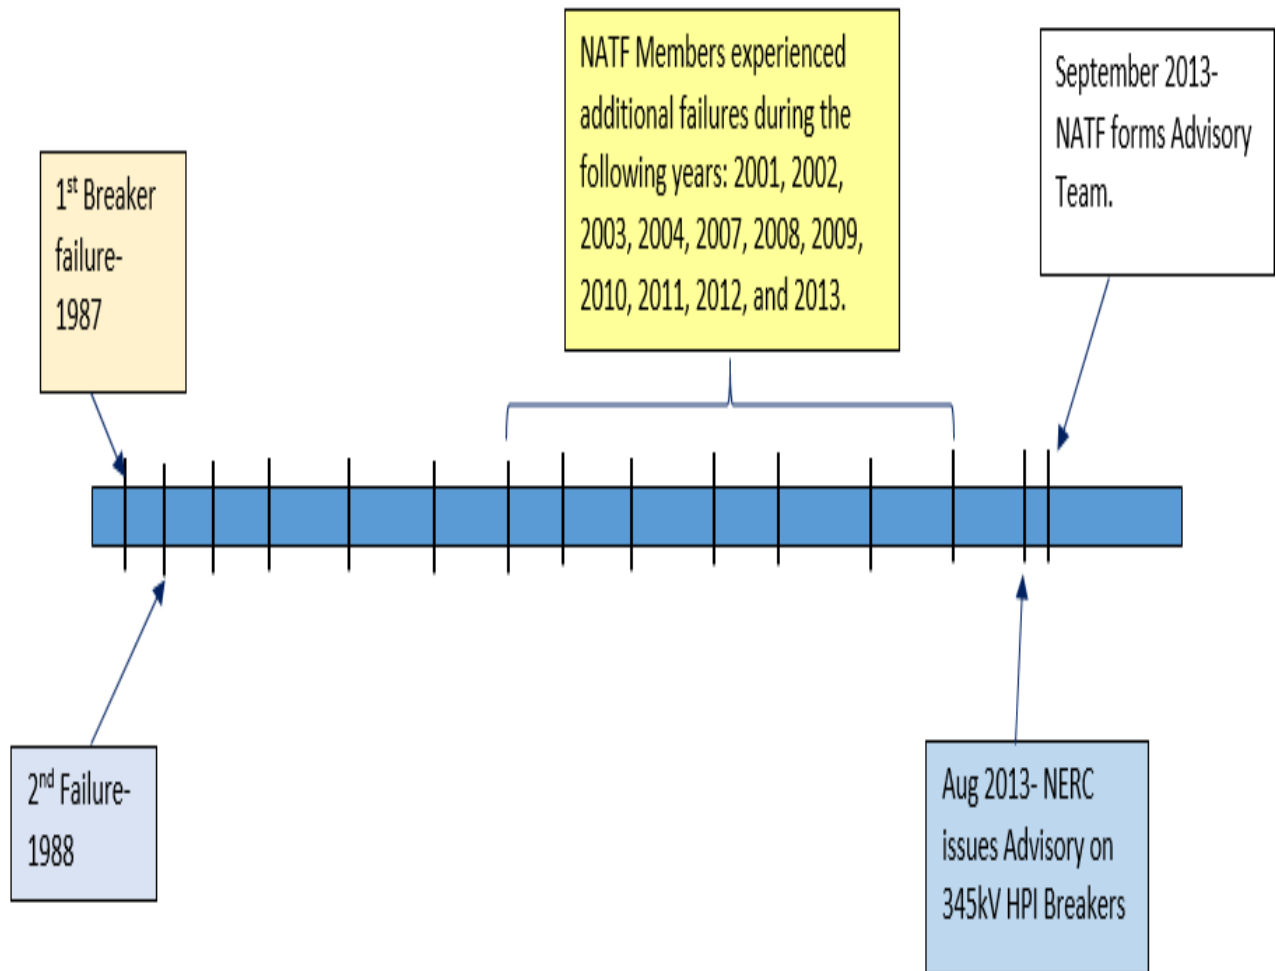
Timeline of Forum Member Breaker Failures

8. For those members who have experienced failures, the number of operations at the time of failure varied from as few as 14 operations to more than 1000, indicating there is no certain threshold whereby exceeding breaker operations it would cause failures to occur.
