Vegetation-Related Transmission Outage Report Second Quarter 2009

The NERC Board of Trustees Compliance Committee has reviewed and accepted this Vegetation-Related Transmission Outage Second Quarter 2009 Report.

Vegetation-related transmission outages that occurred in the second quarter of 2009 are being reported in accordance with standard FAC-003-1.

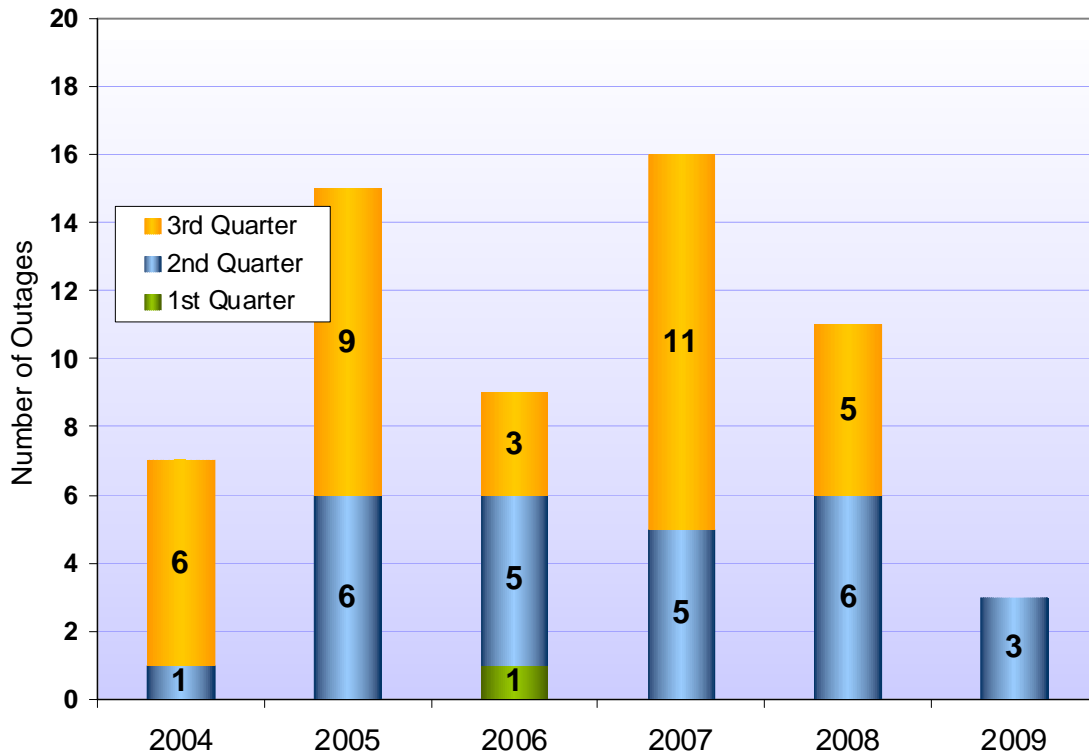
Figure 1: Category 1 — Grow-in Outages Caused by Vegetation Growing into Lines from Inside and/or Outside the ROW.[‡]

[‡] Includes one 2007 Category 1 outage caused by vegetation growing into a RRO-designated critical line <200 kV.
 Second Quarter 2009 Vegetation-Related Transmission Outages
 August 6, 2009

Figure 1 illustrates the number of outages caused by vegetation growing into transmission lines from within the right-of-way that have been reported since 2004. Figure 2 provides this information by voltage class for each year.
