## Vegetation-Related Transmission Outage Report Second Quarter 2010

The NERC Board of Trustees Compliance Committee has reviewed and accepted this Vegetation-Related Transmission Outage Second Quarter 2010 Report.

Vegetation-related transmission outages that occurred in the second quarter of 2010 are being reported in accordance with standard FAC-003-1.

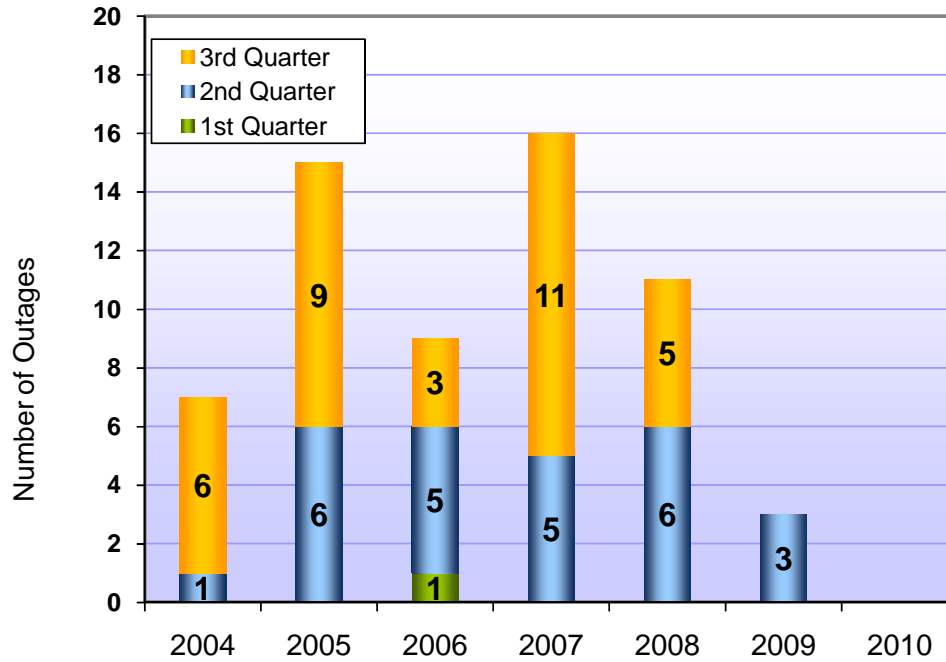
**Figure 1: Category 1 — Grow-in Outages Caused by Vegetation Growing into Lines from Inside and/or Outside the ROW.<sup>‡</sup>**

<sup>‡</sup> Includes one 2007 Category 1 outage caused by vegetation growing into a RRO-designated critical line <200 kV.  
 Second Quarter 2010 Vegetation-Related Transmission Outages  
 September 10, 2010

Figure 1 illustrates the number of outages caused by vegetation growing into transmission lines from within the right-of-way that have been reported since 2004. Figure 2 provides this information by voltage class for each year.

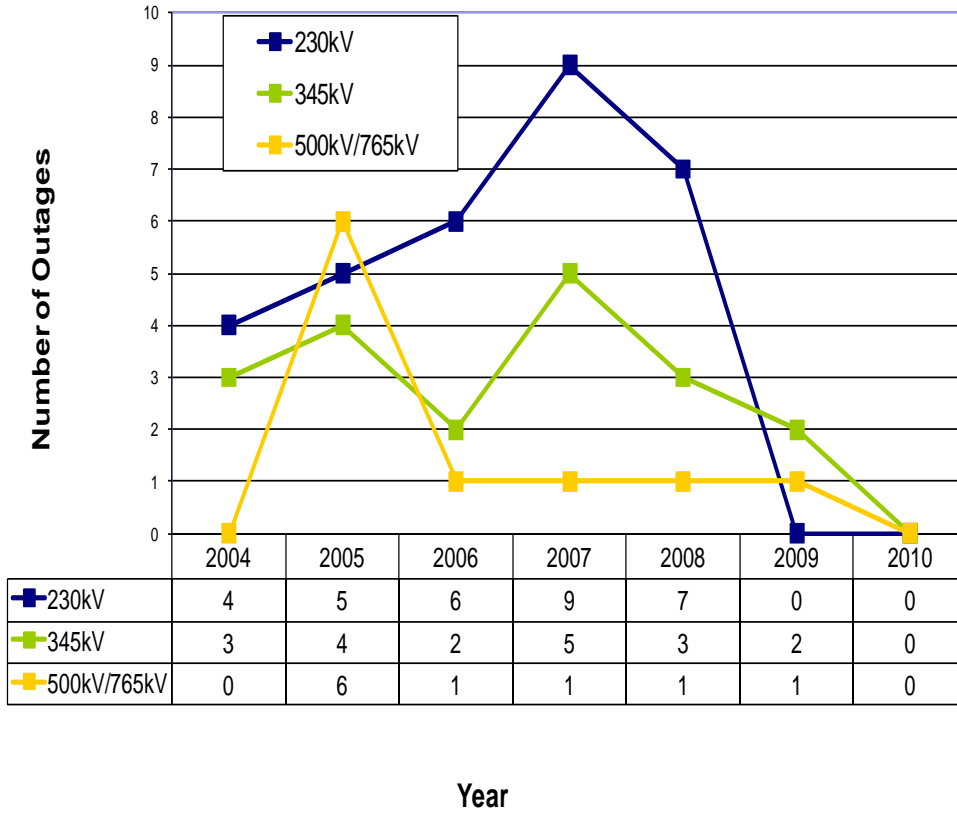
**Figure 2: Category 1 —Grow-In Vegetation Related Outages of 230 kV and Higher Transmission by Voltage Class**
