Vegetation-Related Transmission Outage Report Second Quarter 2011

The NERC Board of Trustees Compliance Committee has reviewed and accepted this Vegetation-Related Transmission Outage Second Quarter 2011 Report.

Vegetation-related transmission outages that occurred in the second quarter of 2011 are being reported in accordance with standard FAC-003-1.

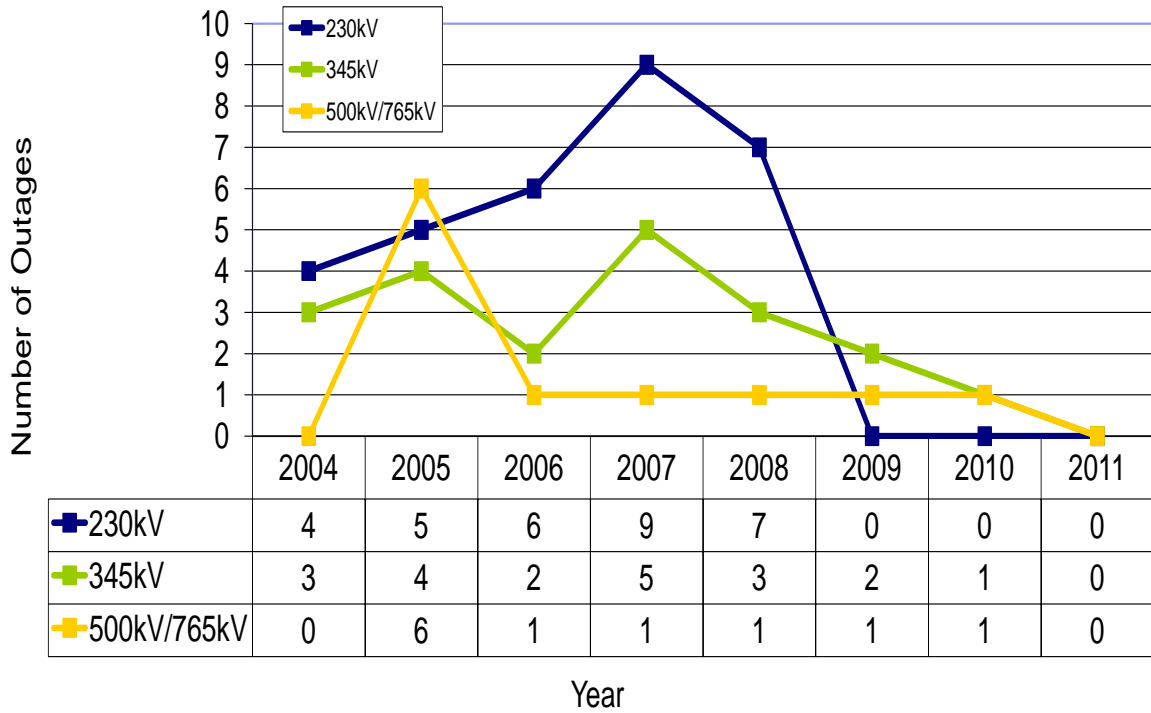
Figure 2: Category 1 —Grow-In Vegetation Related Outages of 230 kV and Higher Transmission by Voltage Class

Table 2 summarizes the number of transmission outages by voltage level, region, and category. Figure 1 illustrates the number of outages caused by vegetation growing into transmission lines from within the right-of-way that have been reported since 2004. Figure 2 provides this information by voltage class for each year.
