**NERC**

# Vegetation-Related Transmission Outage Report

Second Quarter 2014

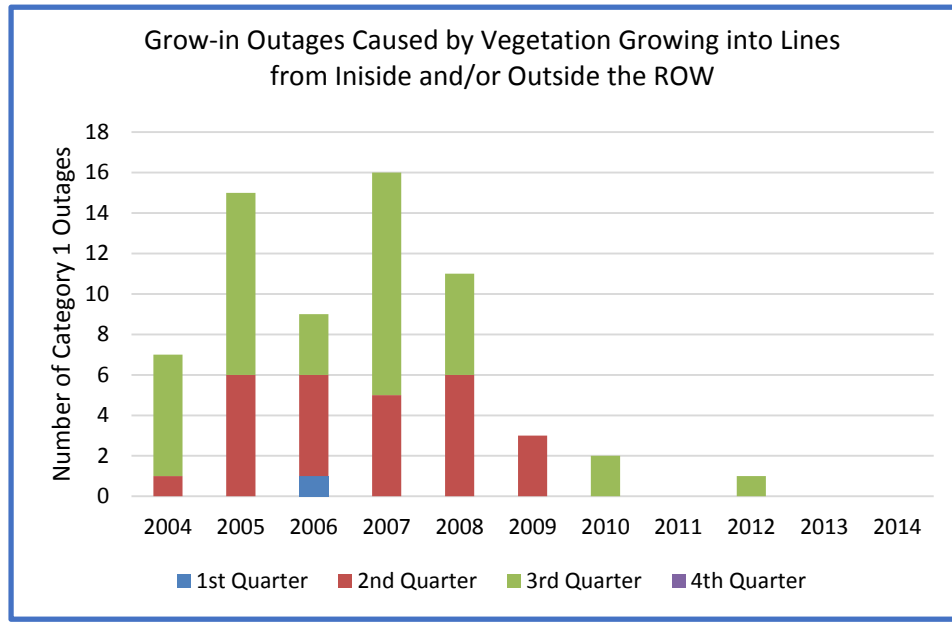
Across the regions, Category 1 outages are increasingly rare due to implementation of the FAC-003 Standard. The following two figures illustrate the decline in the number of outages caused by vegetation growing into transmission lines from within the ROW since 2004.

Figure 1: Grow-in outages from inside and/or outside ROW by reported quarter and year

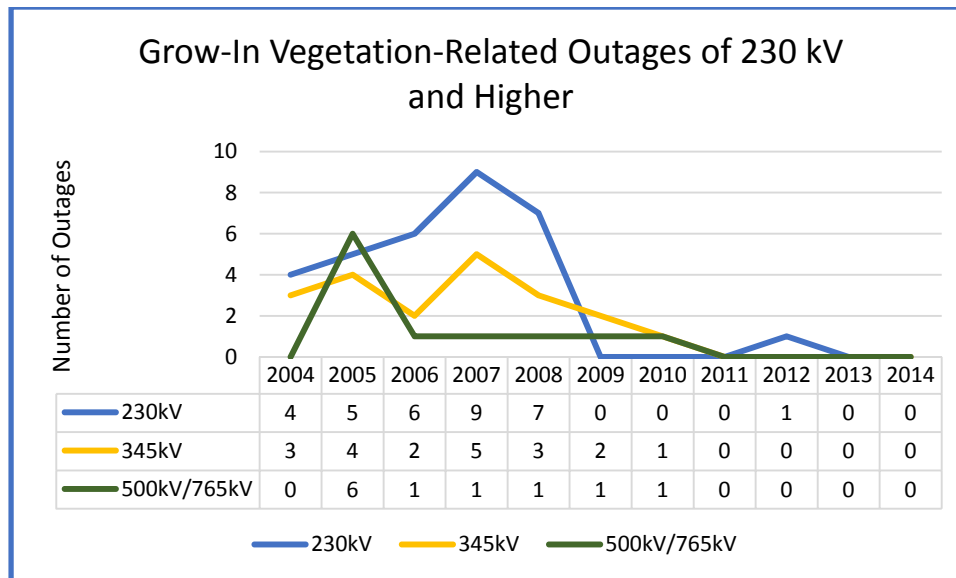
Figure 2: Grow-in vegetation related to outages of 230 kV and other high voltage class transmission line
