Vegetation-Related Transmission Outage Report Third Quarter 2010

The NERC Board of Trustees Compliance Committee has reviewed and accepted this Vegetation-Related Transmission Outage Third Quarter 2010 Report.

Vegetation-related transmission outages that occurred in the third quarter of 2010 are being reported in accordance with standard FAC-003-1.

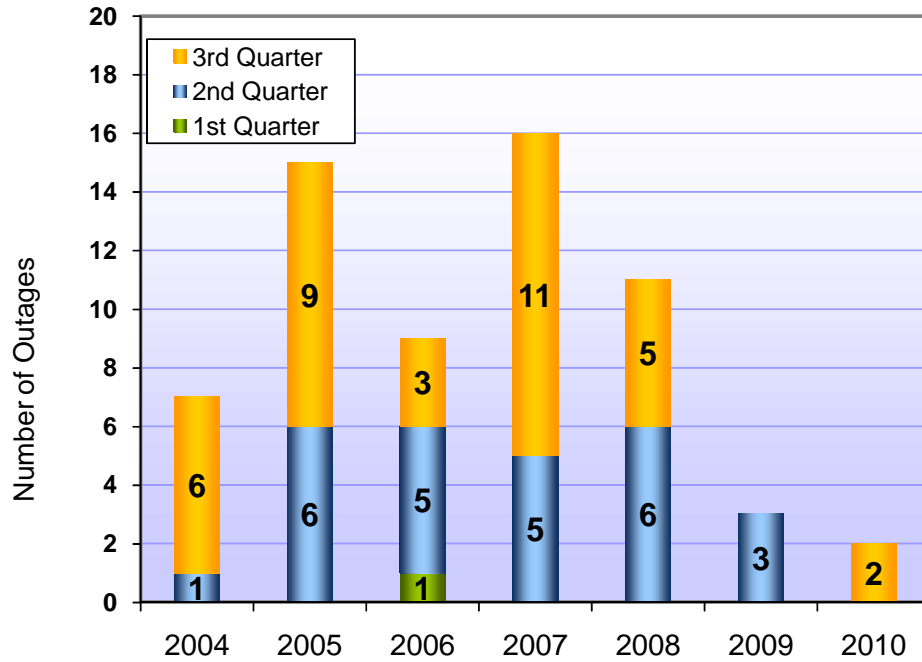
Figure 1: Category 1 — Grow-in Outages Caused by Vegetation Growing into Lines from Inside and/or Outside the ROW.[‡]

[‡] Includes one 2007 Category 1 outage caused by vegetation growing into a RRO-designated critical line <200 kV.
 Third Quarter 2010 Vegetation-Related Transmission Outages

Figure 1 illustrates the number of outages caused by vegetation growing into transmission lines from within the right-of-way that have been reported since 2004. Figure 2 provides this information by voltage class for each year.

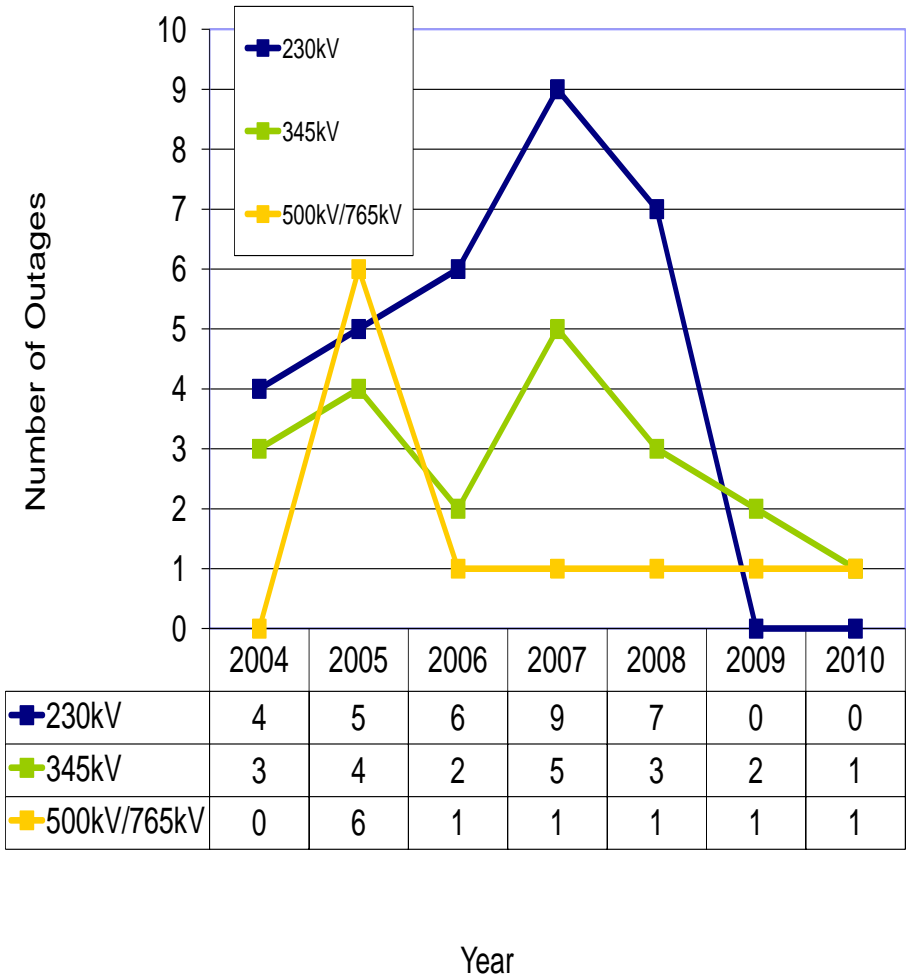
Figure 2: Category 1 —Grow-In Vegetation Related Outages of 230 kV and Higher Transmission by Voltage Class
