NERC

Vegetation–Related Transmission Outage Report

Third Quarter 2013

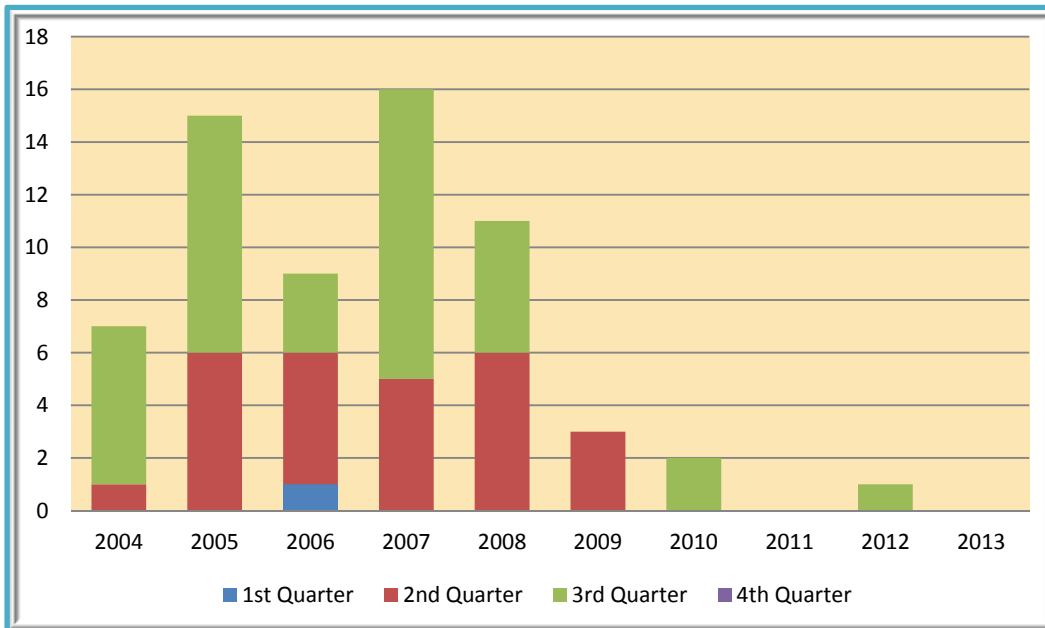
Figure 1 illustrates the number of outages caused by vegetation growing into transmission lines from within the right-of-way that have been reported since 2004.

Figure 1: Category 1 — Grow-in Outages Caused by Vegetation Growing into Lines from Inside and/or Outside the ROW.⁵

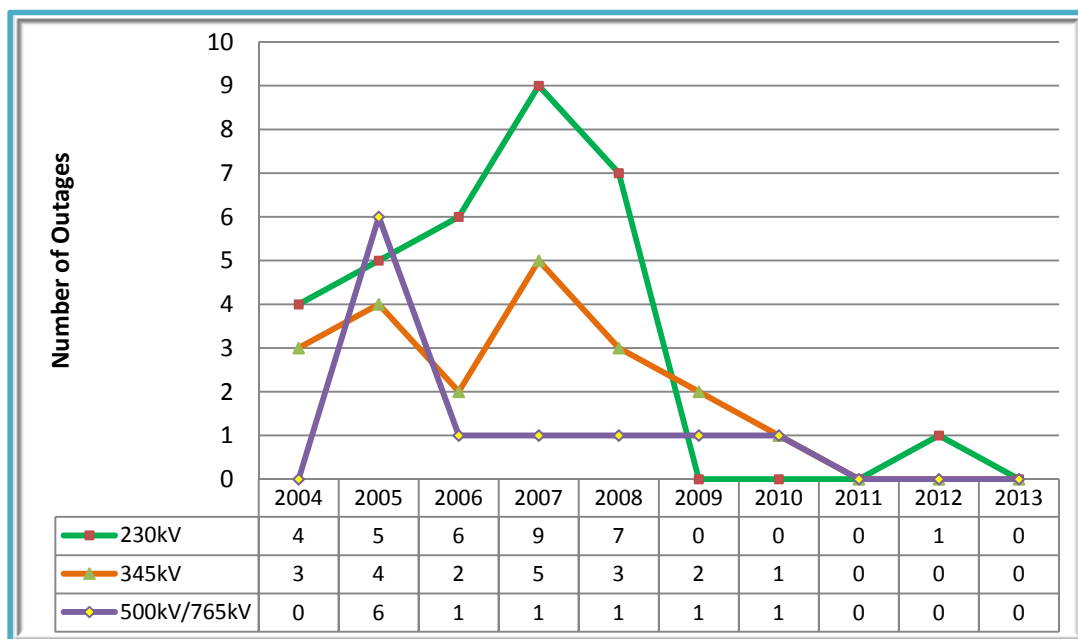
Figure 2 provides this information by voltage class for each year.

Figure 2: Category 1 —Grow-In Vegetation Related Outages of 230 kV and Higher
