NORTH AMERICAN ELECTRIC  
RELIABILITY CORPORATION

# Vegetation–Related Transmission Outage Report

Second Quarter 2013

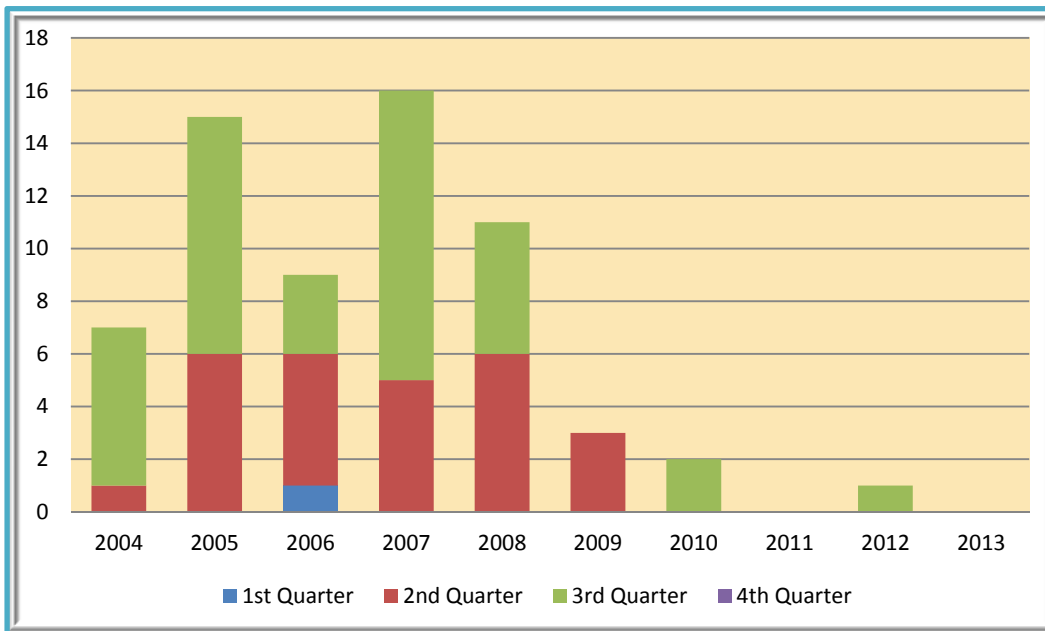
Figure 1 illustrates the number of outages caused by vegetation growing into transmission lines from within the right-of-way that have been reported since 2004.

Figure 1: Category 1 — Grow-in Outages Caused by Vegetation Growing into Lines from Inside and/or Outside the ROW.<sup>5</sup>

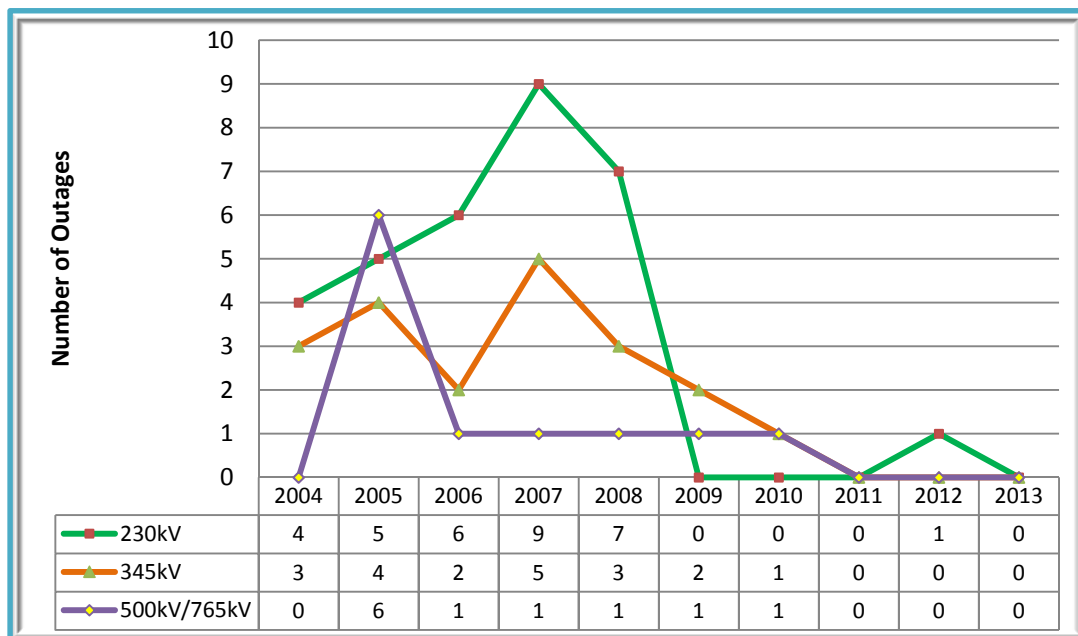
Figure 2 provides this information by voltage class for each year.

Figure 2: Category 1 — Grow-In Vegetation Related Outages of 230 kV and Higher
