## Vegetation-Related Transmission Outage Report First Quarter 2009

The NERC Board of Trustees Compliance Committee has reviewed and accepted this Vegetation-Related Transmission Outage First Quarter 2009 Report.

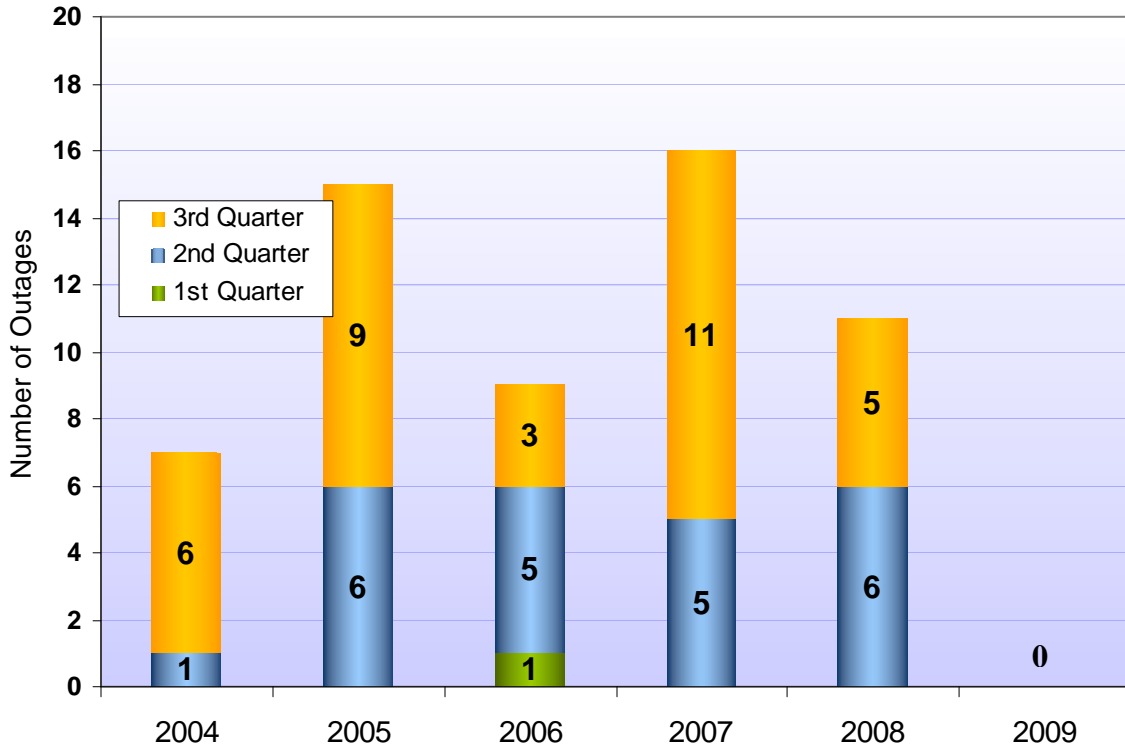
**Figure 1: Category 1 — Grow-in Outages Caused by Vegetation Growing into Lines from Inside and/or Outside the ROW. ‡**

‡ Includes one 2007 Category 1 outage caused by vegetation growing into a RRO-designated critical line <200 kV.

Figure 1 illustrates the number of outages caused by vegetation growing into transmission lines from within the right-of-way that have been reported since 2004. Figure 2 provides this information by voltage class for each year.

\* Contains only sustained outages of transmission lines and does not include violations resulting from momentary outages or encroachments into the clearance zone as described in standard FAC-003.

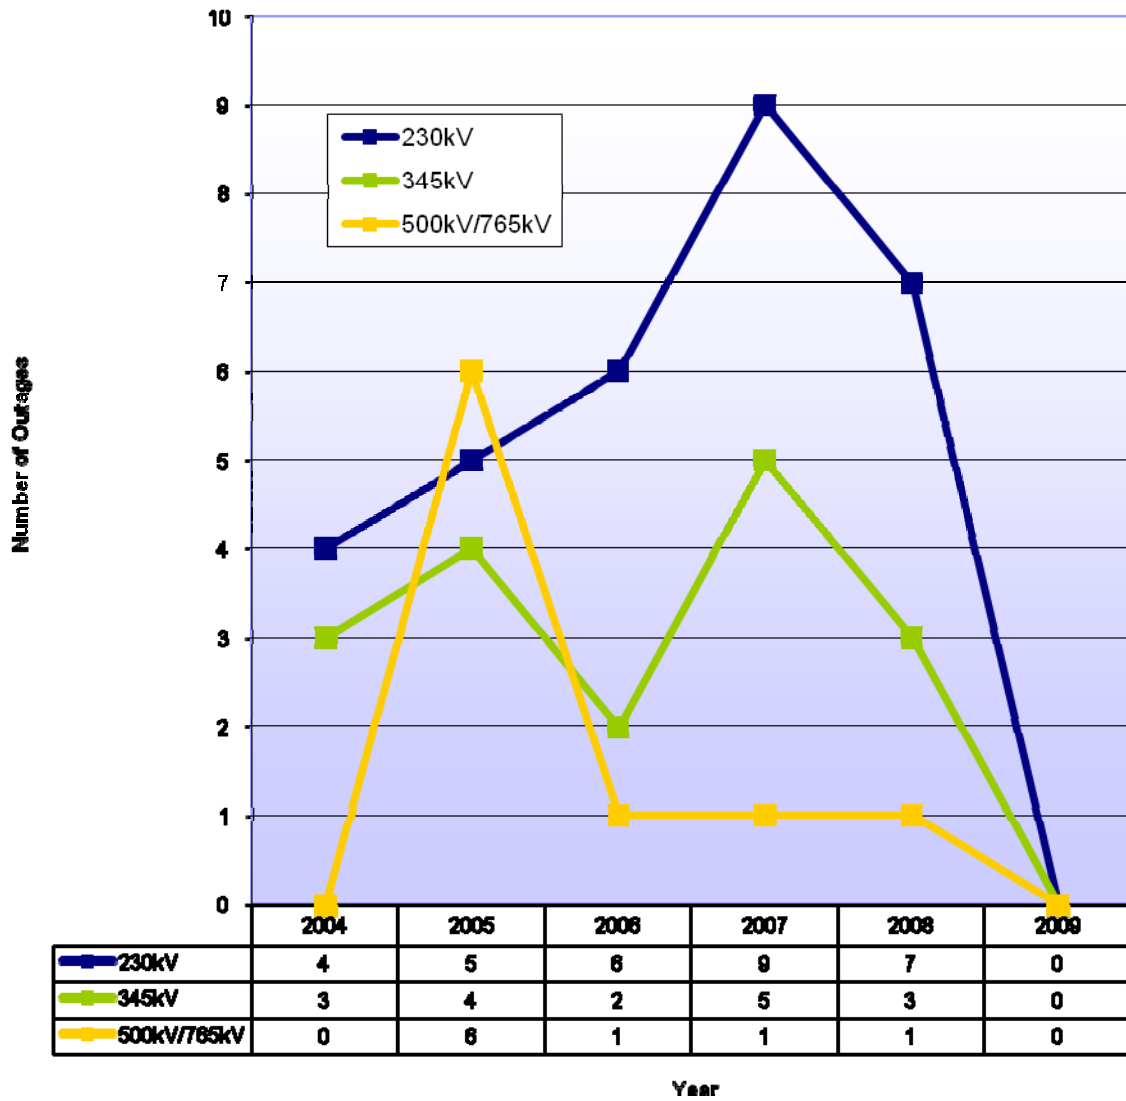
**Figure 2: Category 1 —Grow-In Vegetation Related Outages of 230 kV and Higher Transmission by Voltage Class**
