Vegetation-Related Transmission Outage Report Second Quarter 2008

The NERC Board of Trustees Compliance Committee has reviewed and accepted this Vegetation-Related Transmission Outage Second Quarter 2008 Report.

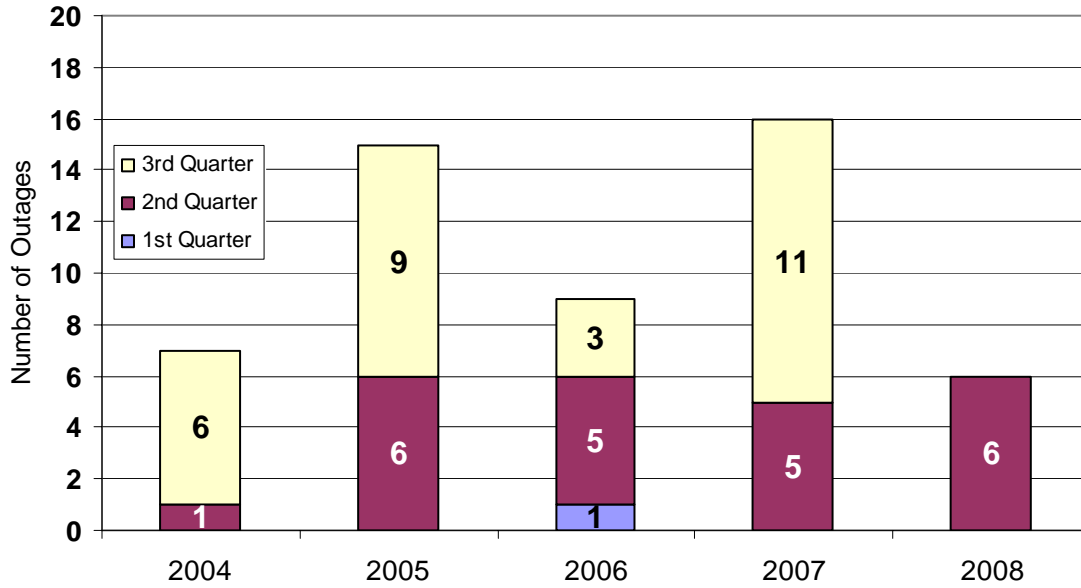
TOTAL			4-<200 kV 10-230 kV	5-230 kV 1-500 kV		4-230 kV 1-<200 kV							5-230 kV 1-500 kV		5-<200 kV 14-230 kV

Figure 1: Category 1 — Grow-ins from within the Right-of-Way

Figure 1 illustrates the number of outages caused by vegetation growing into transmission lines from within the right-of-way that have been reported since 2004. Figure 2 provides this information by voltage class for each year.

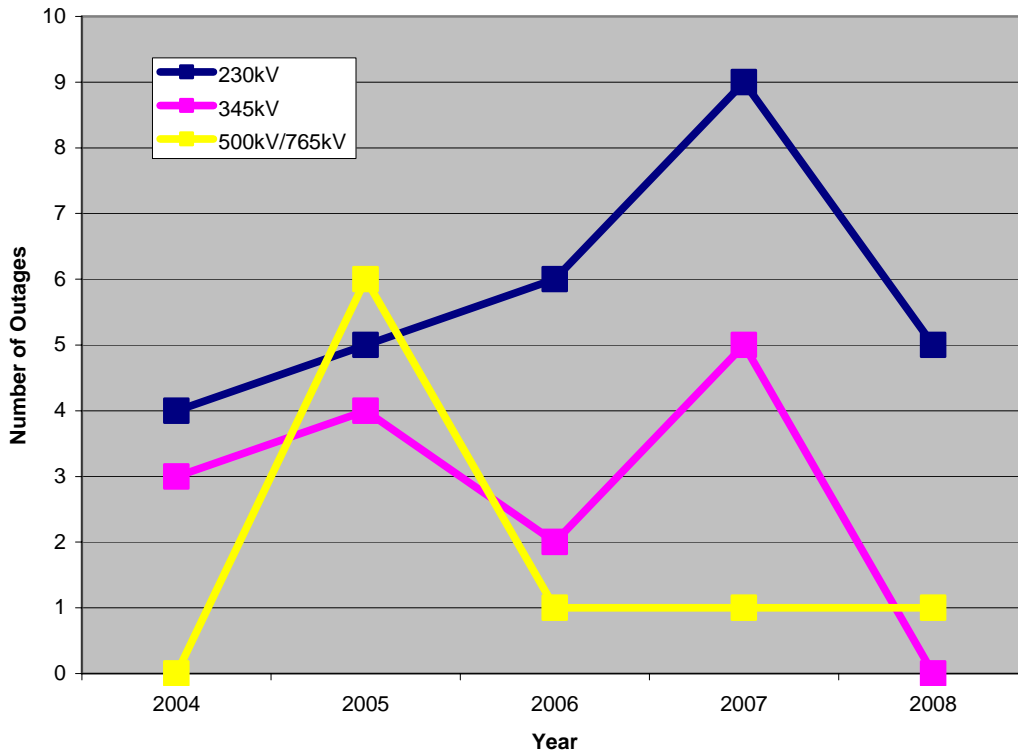
Figure 2: Category 1 — Grow-In Vegetation Related Outages of 230 kV and Higher Transmission within the Right-of-Way by Voltage Class
