Vegetation-Related Transmission Outage Report Fourth Quarter 2008

The NERC Board of Trustees Compliance Committee has reviewed and accepted this Vegetation-Related Transmission Outage Fourth Quarter 2008 Report.

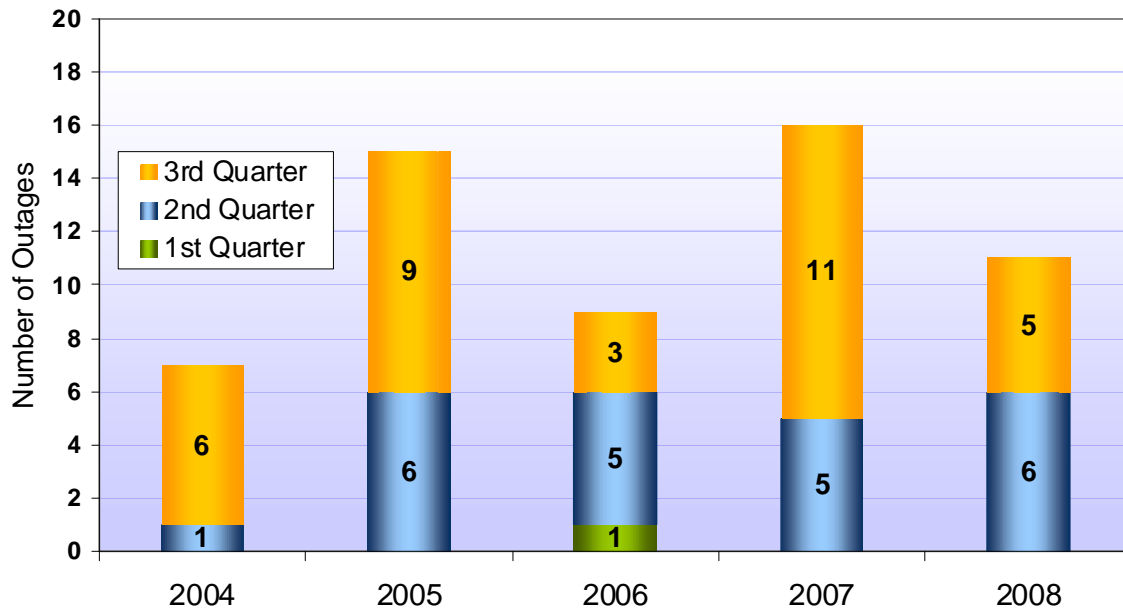
Figure 1: Category 1 — Grow-in Outages Caused by Vegetation Growing into Lines from Inside and/or Outside the ROW. ‡

‡ Includes one 2007 Category 1 outage caused by vegetation growing into a RRO-designated critical line <200 kV.

Figure 1 illustrates the number of outages caused by vegetation growing into transmission lines from within the right-of-way that have been reported since 2004. Figure 2 provides this information by voltage class for each year.

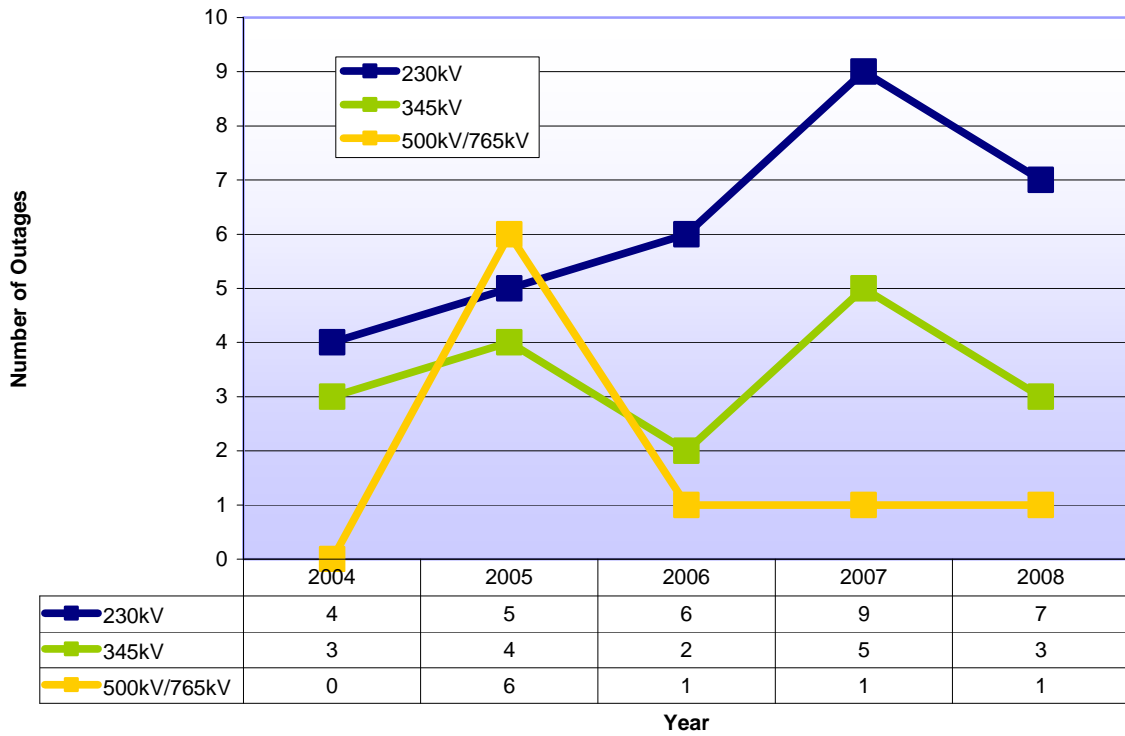
Figure 2: Category 1 —Grow-In Vegetation Related Outages of 230 kV and Higher Transmission by Voltage Class
