FAC-003-3 Minimum Vegetation Clearance Distances

May 12, 2015

Executive Summary

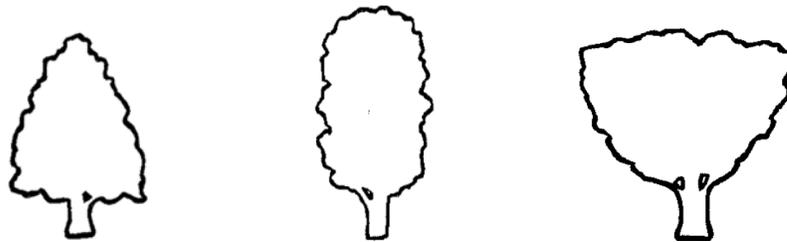
- Pyramidal – Conifers (e.g., spruce, fir, pine) that have a well-defined central leader.
- Columnar – Deciduous trees that may exhibit less central dominance, commonly referred to as having a random form.
- Broadly vase-shaped – Involves larger trees with crowns that have been maintained by pruning. This is produced by the inability to remove trees within the conductor zone. The crown form would be asymmetrical or perhaps even “flat-topped.”

Figure 1: Vegetation Shapes Tested for Vertical Conductor-to-Vegetation Gaps – Pyramidal, Columnar, and Vase

Vegetation species vary both regionally and by site type. The test was designed to cover the range of vegetation shapes and types expected in and around transmission rights-of-way for all NERC Regional Entities. It was important to test various vegetation shapes, as they produce varying influences on the electric field between a transmission line conductor and vegetation. These influences were found to affect the probability of flashover between a conductor and vegetation and must be considered to determine the minimum value of the gap factor for a given conductor-to-vegetation gap configuration. The different types of vegetation were organized into three basic shapes, as illustrated in Figure 1.

gap configurations were incorporated into the test plan. All three vegetation shapes were tested in the vertical conductor-to-vegetation gap configuration, since they may produce varying electric field influences between a conductor and vegetation, as noted above.

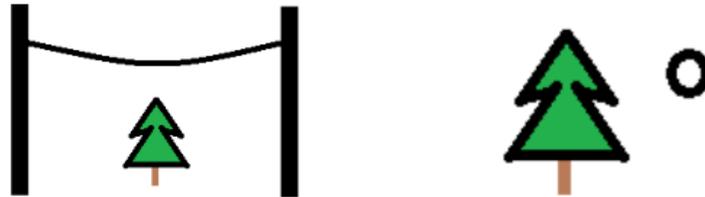
The physical arrangements of both the vegetation and transmission line conductors were also considered when determining the types of conductor-to-vegetation gap configurations that were tested. Encroachment between vegetation and transmission lines could occur vertically (from below) or horizontally (from the side), as illustrated in Figure 2. Both vertical and horizontal conductor-to-vegetation

Figure 2: Vertical (Grow-in) and Horizontal (Blow-in) Conductor-to-Vegetation Gap Configurations

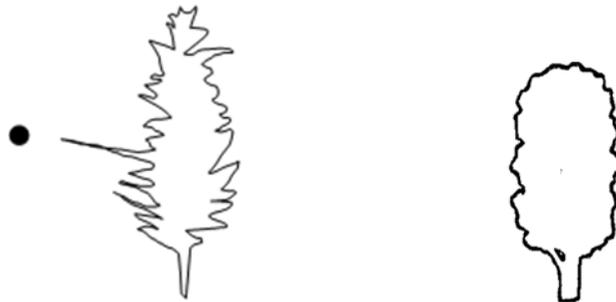
Concerning horizontal conductor-to-vegetation gap configurations, vegetation shape varies based on maintenance practices. When viewed from the side, maintained vegetation appears planar in shape. However, vegetation that has not been maintained may have a less-consistent appearance, with branches that protrude out toward a transmission line. The horizontal conductor-to-vegetation gap configurations were tested for both columnar geometry (i.e., maintained look) and modified columnar form of vegetation that simulates a branch protruding toward a transmission line, as illustrated in Figure 3.

Figure 3: Vegetation Shapes Tested for Horizontal Conductor-to-Vegetation Gaps – Branch Protruding Toward Conductor and Columnar
